# MISSISSIPPI ASBESTOS DEMOLITION/RENOVATION NOTIFICATION FORM

RE: Asbestos Inspection Services  
Winona-Montgomery Consolidated School District  
Former Knox School – Two Abandoned Buildings  
Winona, Mississippi

**ASBESTOS-CONTAINING MATERIALS  
SURVEY AND ASSESSMENT**

**WINONA-MONTGOMERY CONSOLIDATED SCHOOL DISTRICT  
FORMER KNOX SCHOOL  
TWO ABANDONED BUILDINGS**

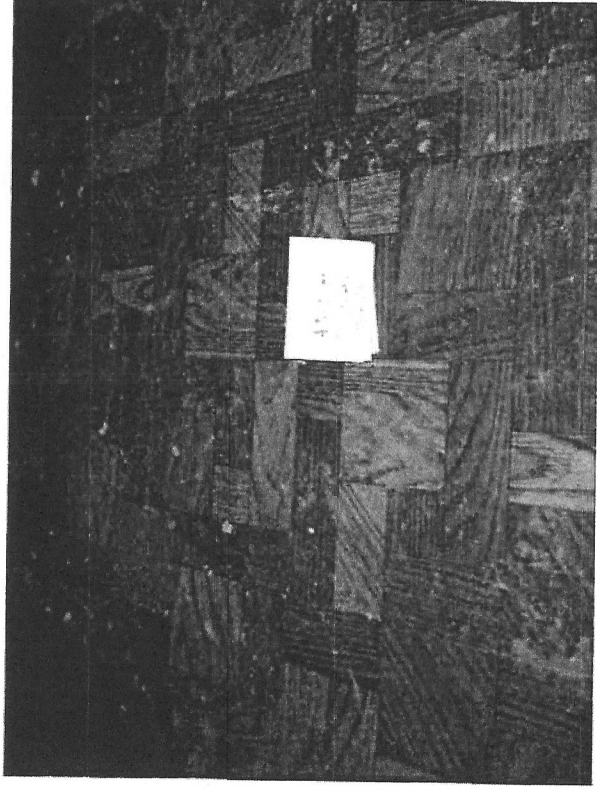
- **Black adhesive beneath 12-inch "ceramic pattern" linoleum floor tile HA (AB-01).** This material is located in the main room of the former Knox Church, on the west side of the building. Material and sample locations are shown in Appendix 4.2. Laboratory analysis revealed that this material contains approximately 2% chrysotile asbestos in the adhesive. This material is in good condition and classified as a Category II, non-friable ACM according to National Emission Standards for Hazardous Air Pollutants (NESHAP) regulations.

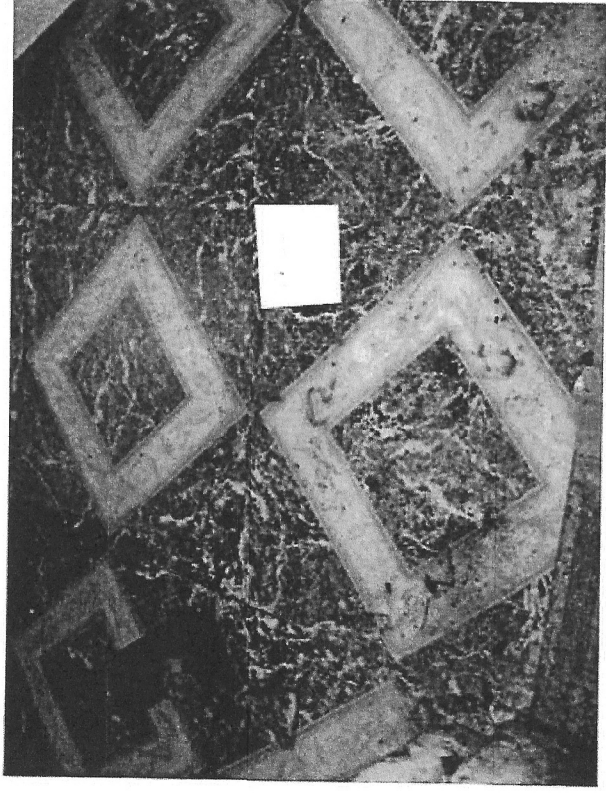
- **Black adhesive beneath 12-inch "Mexican pattern" linoleum floor tile HA (AB-02).** This material is located in two rooms along the south side of the former Knox Church building. Material and sample locations are shown in Appendix 4.2. Laboratory analysis revealed that this material contains approximately 2% chrysotile asbestos in the adhesive. This material is in fair condition and classified as a Category II, non-friable ACM according to NESHAP regulations.

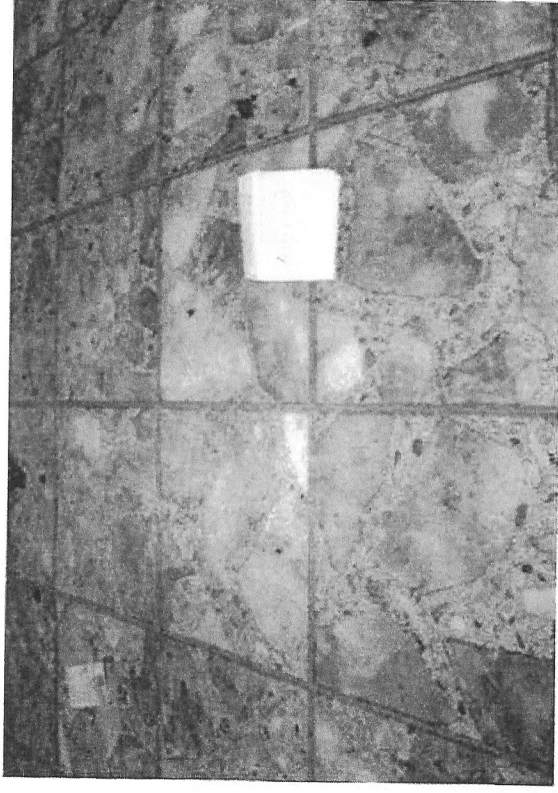
- **Black adhesive beneath “ceramic square pattern” linoleum roll flooring HA (AB-03).** This material is located in one room of the former Knox Church building, at the southwest corner of the building. Material and sample locations are shown in Appendix 4.2. Laboratory analysis revealed that this material contains approximately 5% chrysotile asbestos in the adhesive. This material is in good condition and classified as a Category II, non-friable ACM according to NESHAP regulations.

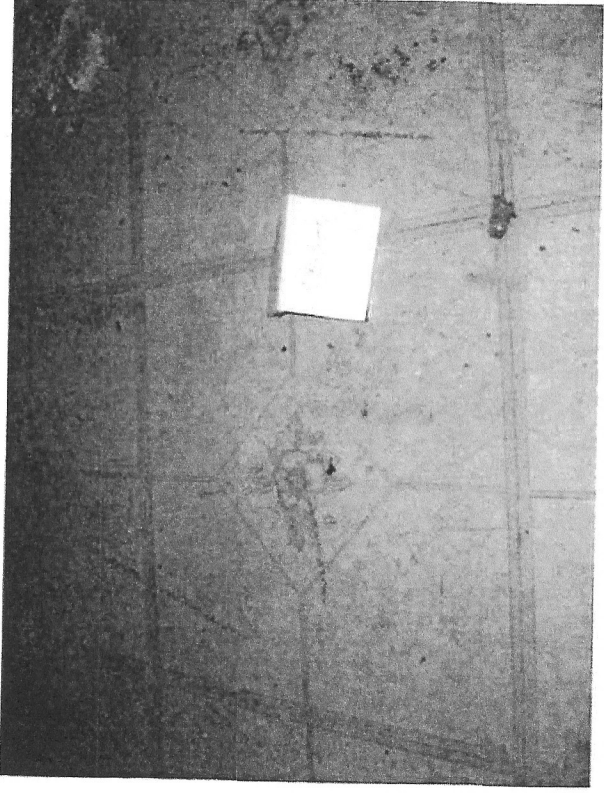
- **Black Adhesive beneath 12-inch white linoleum floor tile HA (AB-05).** This material is located in a central room of the former Knox Church building. Material and sample locations are shown in Appendix 4.2. Laboratory analysis revealed that this material contains approximately 3% chrysotile asbestos in the adhesive. This material is in good condition and classified as a Category II, non-friable ACM according to NESHAP regulations.

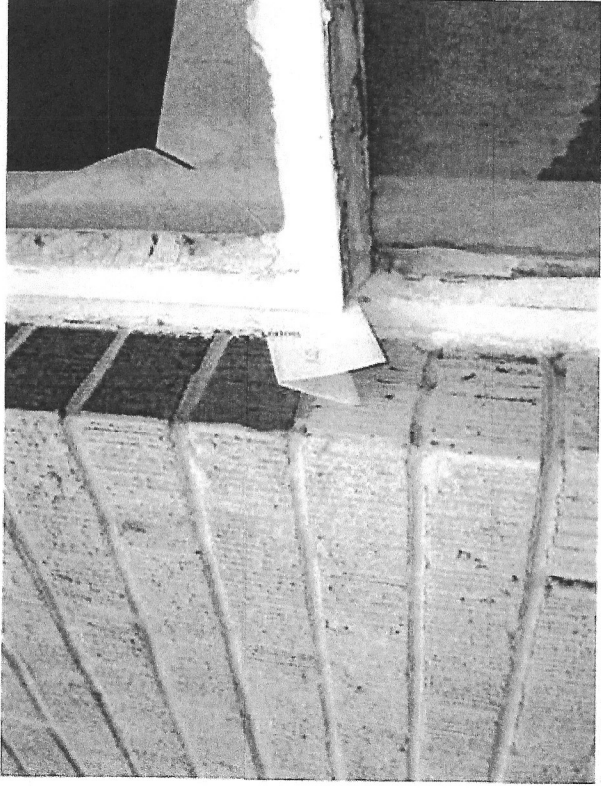
- **Exterior window caulking around perimeter HA (AB-11).** This material is located around the perimeters of the exterior window frames of the former Knox Church building. Material and sample locations are shown in Appendix 4.2. Laboratory analysis revealed that this material contains approximately 4% chrysotile asbestos in the adhesive. This material is in good condition and classified as a Category II, non-friable ACM according to NESHAP regulations.

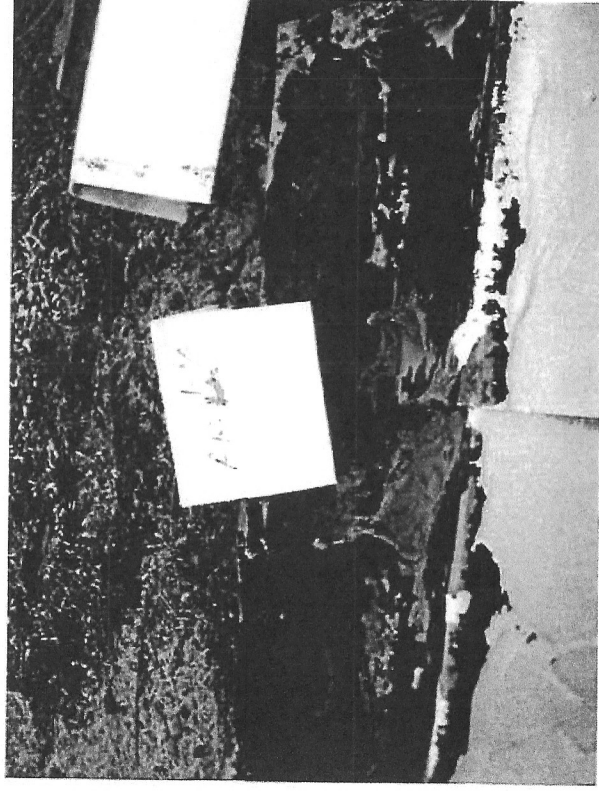
Gray coating around roof perimeter HA (AB-14). This material is located around the perimeter of the roof of the former Knox Church building. Material and sample locations are shown in Appendix 4.2. Laboratory analysis revealed that this material contains approximately 8% chrysotile asbestos in the adhesive. This material is in good condition and classified as a Category I, non-friable ACM according to NESHAP regulations.

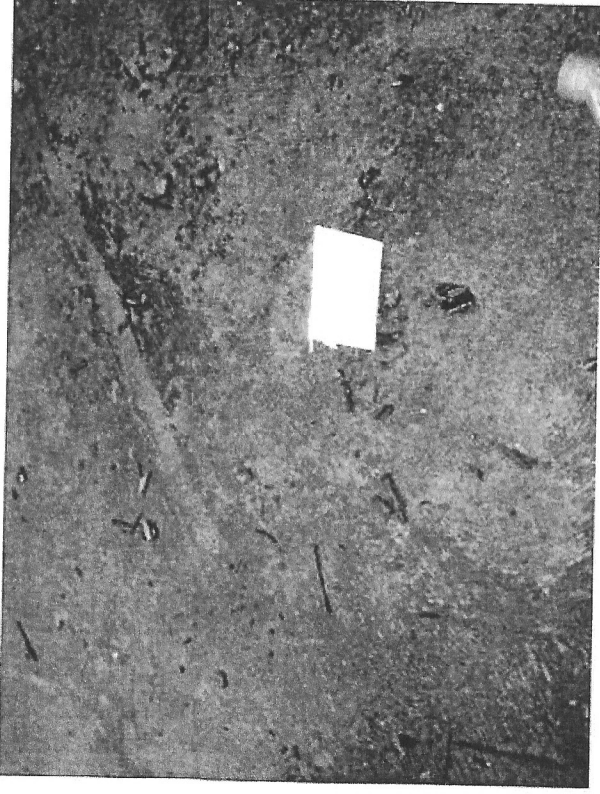
- **Black mastic on exposed concrete floors HA (AB-2-01).** This material is located on the exposed concrete floors of the second abandoned building. Material and sample locations are shown in Appendix 4.2. Laboratory analysis revealed that this material contains approximately 6% chrysotile asbestos in the adhesive. This material is in good condition and classified as a Category II, non-friable ACM according to NESHAP regulations.

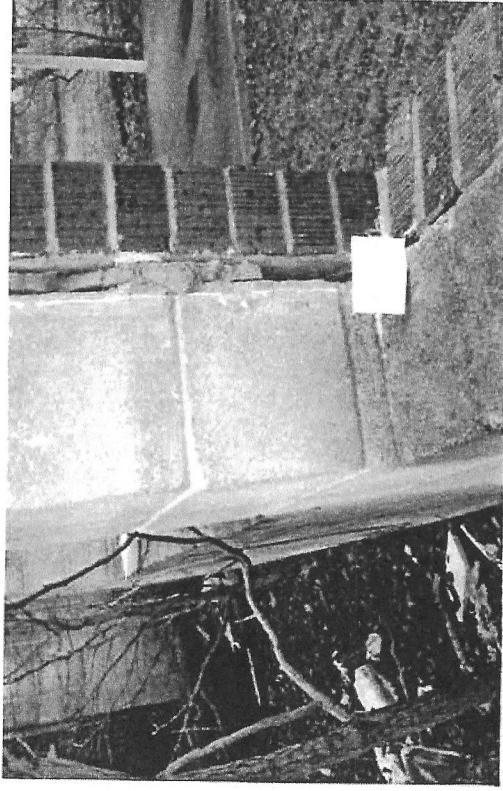
- **Exterior window caulking HA (AB-2-04).** This material is located around the exterior perimeter of the windows in the second abandoned building. Material and sample locations are shown in Appendix 4.2. Laboratory analysis revealed that this material contains approximately 6% chrysotile asbestos in the adhesive. This material is in good condition and classified as a Category II, non-friable ACM according to NESHAP regulations.
