ASBESTOS INSPECTION

RESIDENTIAL STRUCTURES - COOKOUT, COLUMBUS, MISSISSIPPI

503 18TH AVENUE NORTH
COLUMBUS, MISSISSIPPI 39705

ECS PROJECT NO. 49:25354

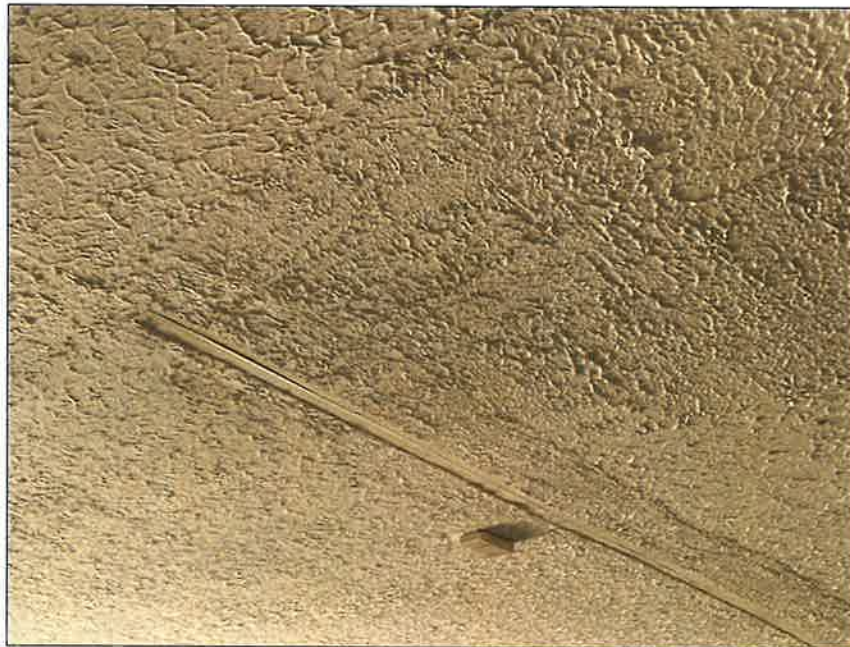
10 - Western Structure - White Ceiling Texture (CTX1)

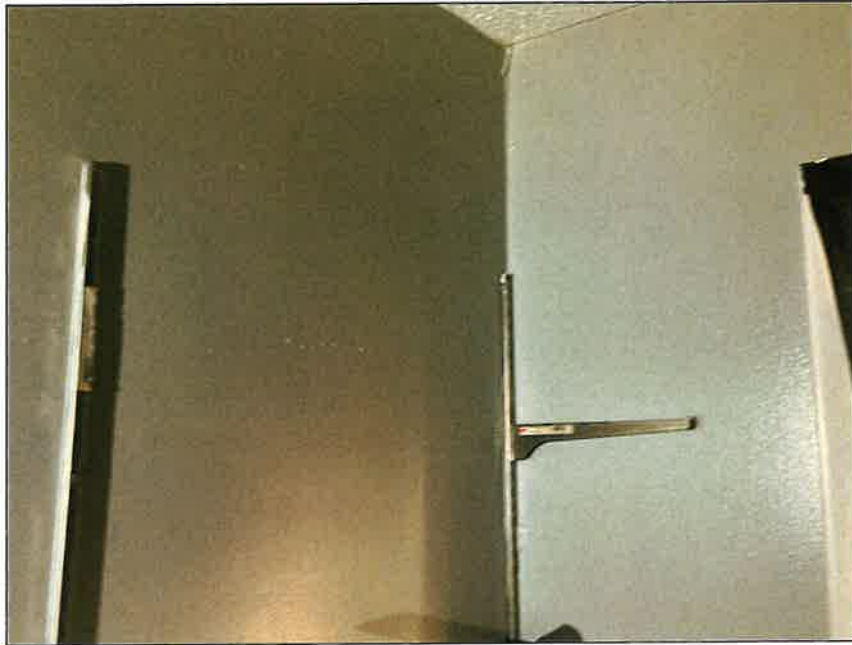
A trace amount of asbestos ($\leq 1\%$) was detected in the composite analysis of bulk samples of joint compound and associated drywall from the western residence analyzed by the laboratory. Although materials that contain trace amounts of asbestos are not subject to U.S. EPA or Mississippi regulations for the handling and disposal of asbestos, OSHA still regulates any work which will disturb materials identified with trace amounts of asbestos (reference the November 24, 2003 OSHA Interpretation document - Compliance Requirements For Renovation Work Involving Materials Containing Less Than 1% Asbestos). Therefore, any Contractors disturbing these materials will need to comply with components of 29 CFR 1926.1101, as detailed in the 2003 OSHA Interpretation document.

11 - Western Structure - Non-ACM Joint Compound and Drywall (DW1)

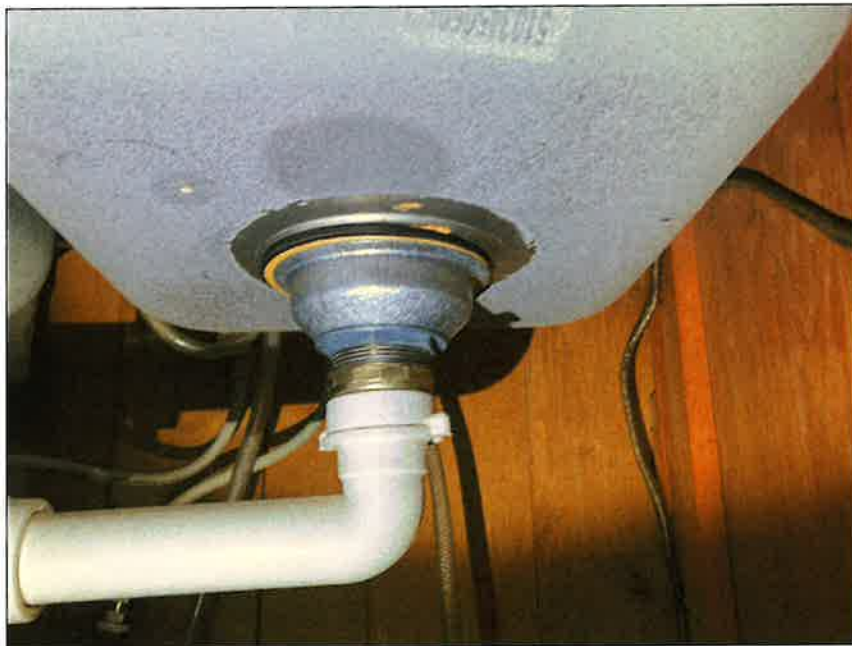
12 - Western Structure - Non-ACM Grey Sink Undercoating (SU1)

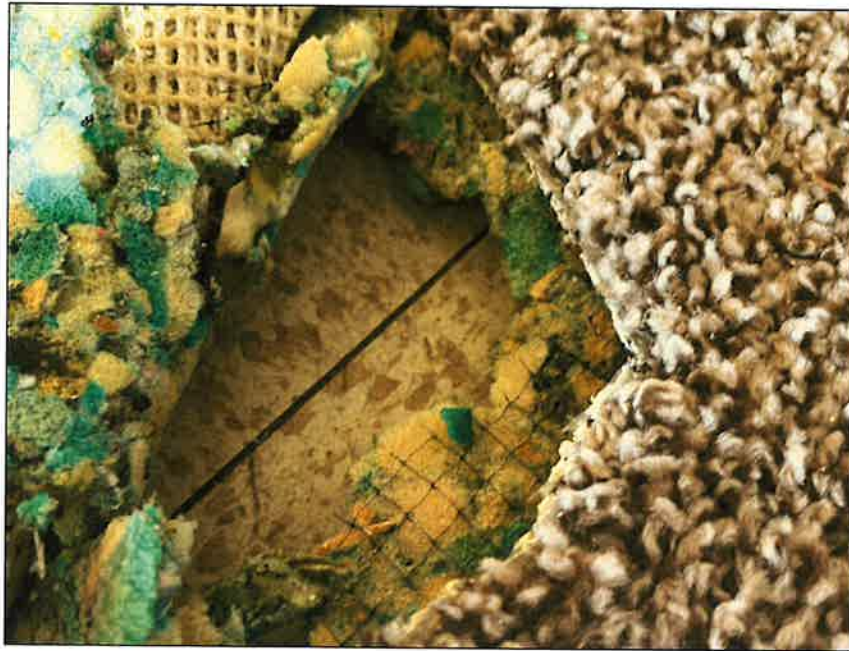
13 - Western Structure - ACM 12" x 12" Tan Floor Tile and Mastic (FL1)

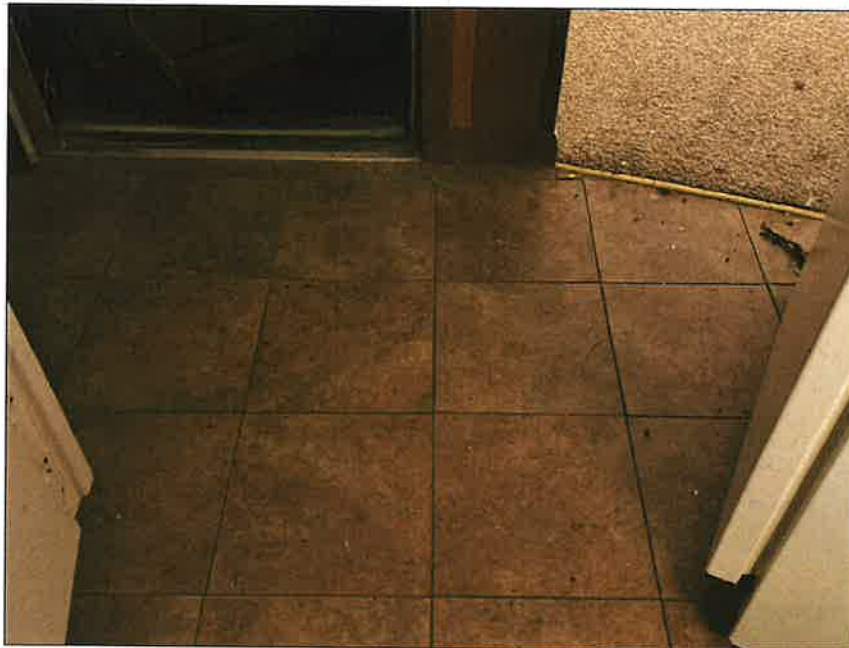
14 - Western Structure - Non-ACM Floor Tile with underlying ACM Vinyl Sheet Flooring (FL2)

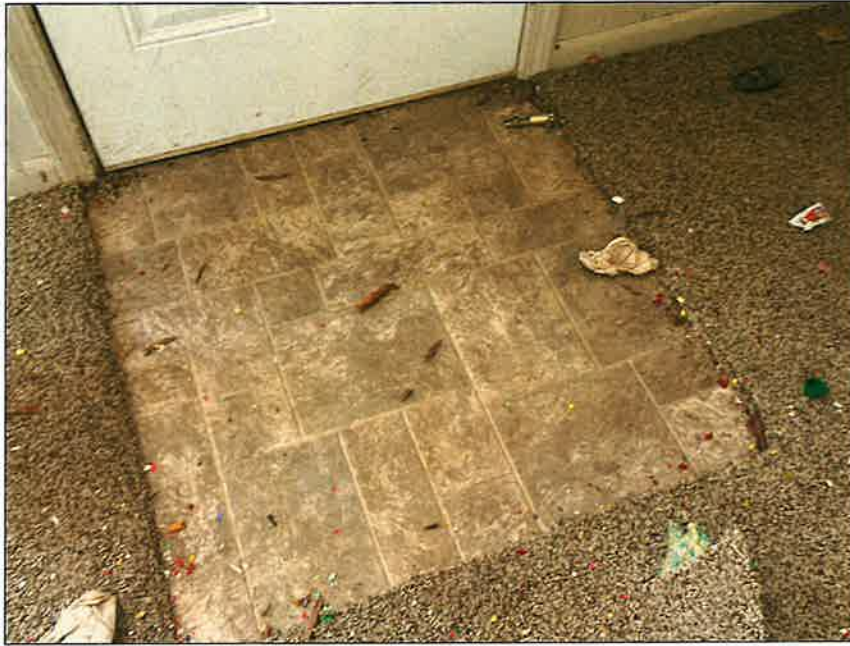
15 - Western structure - Non-ACM Vinyl Sheet Flooring atop ACM Vinyl Sheet Flooring (FL3)

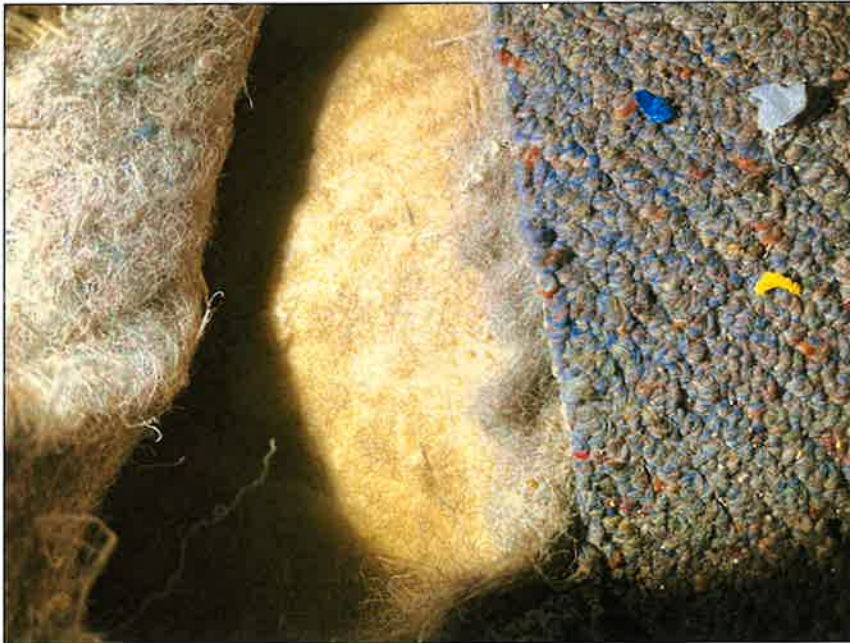
16 - Western structure - Non-ACM Off-white Vinyl Sheet Flooring (FL4)

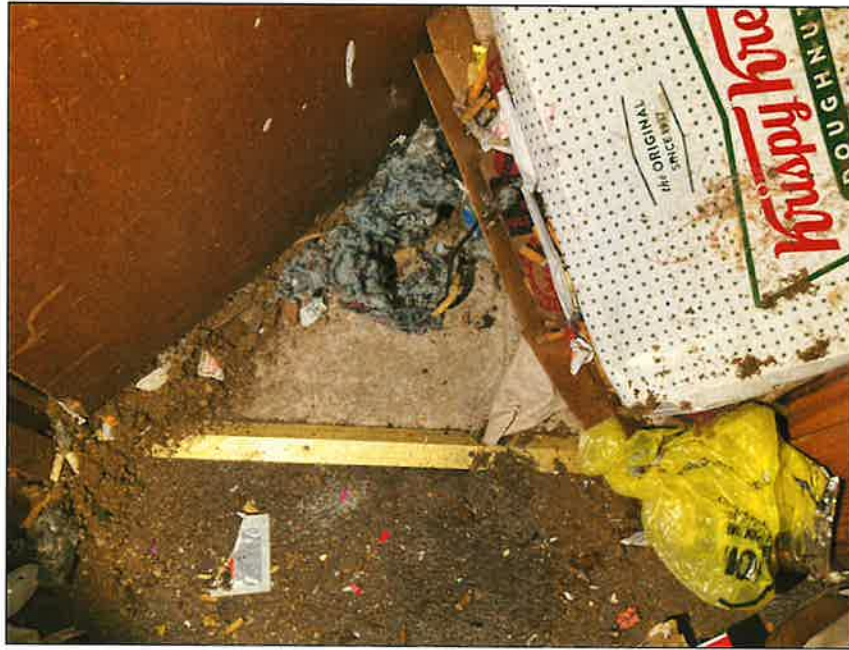
17 - Western structure - Non-ACM Pinkish-Grey Vinyl Sheet Flooring (FL5)

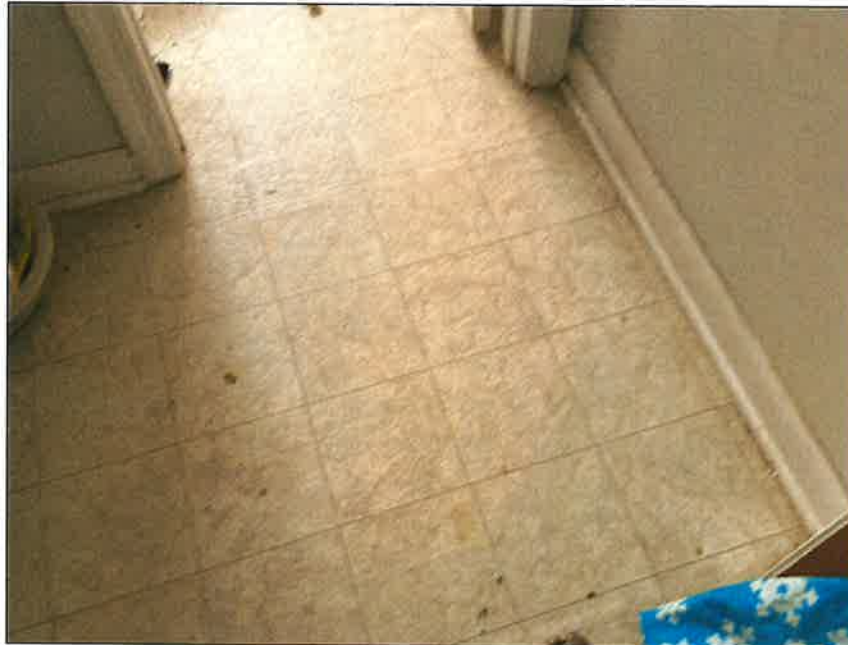
18 - Western Structure - Non-ACM Off-white Vinyl Sheet Flooring (FL6)

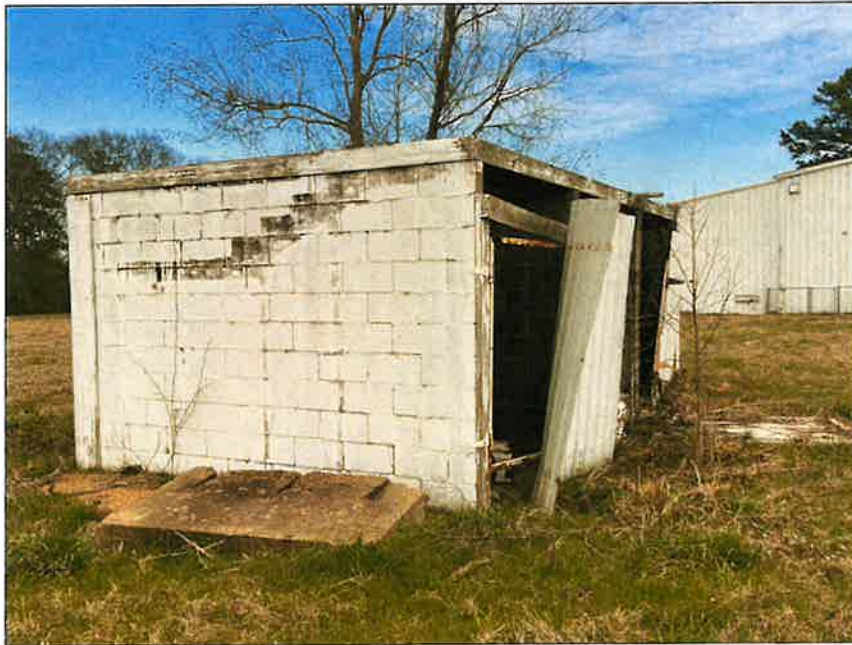
20 - Center Structure - Non-ACM White/Grey CMU Coat (CO1)

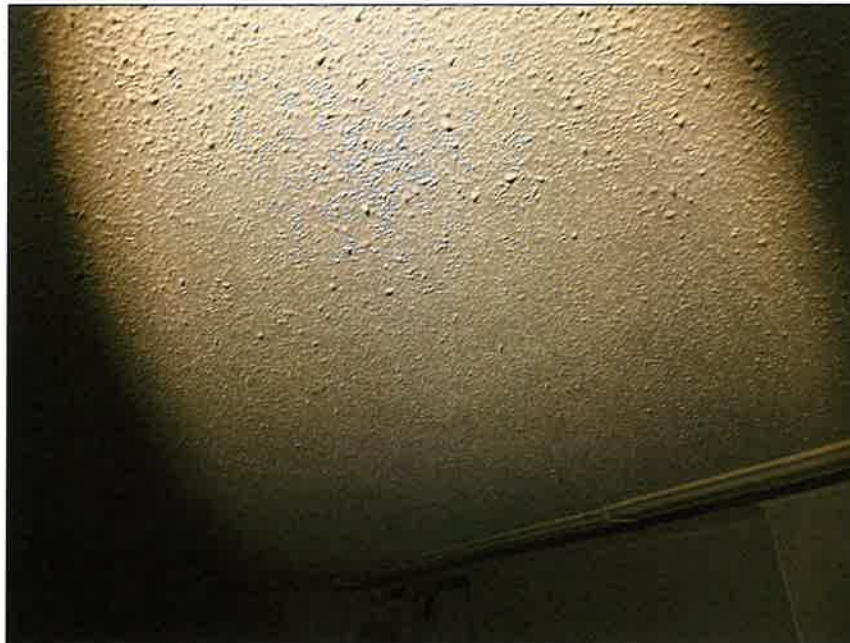
28 - Eastern Structure - ACM White Ceiling Texture ("Popcorn" Style) (CTX1)

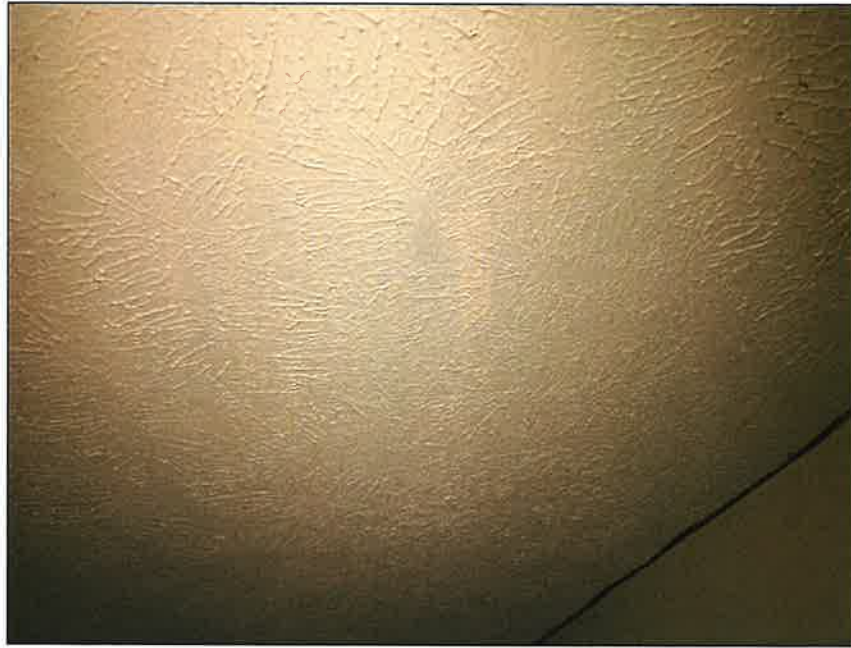
29 - Eastern Structure - Non-ACM White Ceiling Texture ("Stipple" Style) (CTX2)

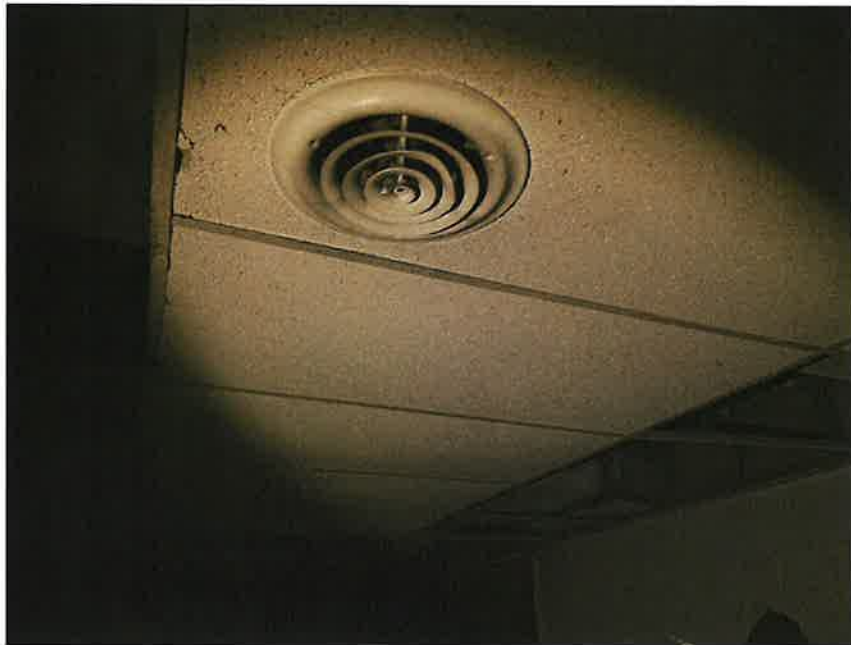
30 - Eastern Structure - Non-ACM 2' x 4' White Ceiling Tile (Pinholes and Fissures) (CTL1)

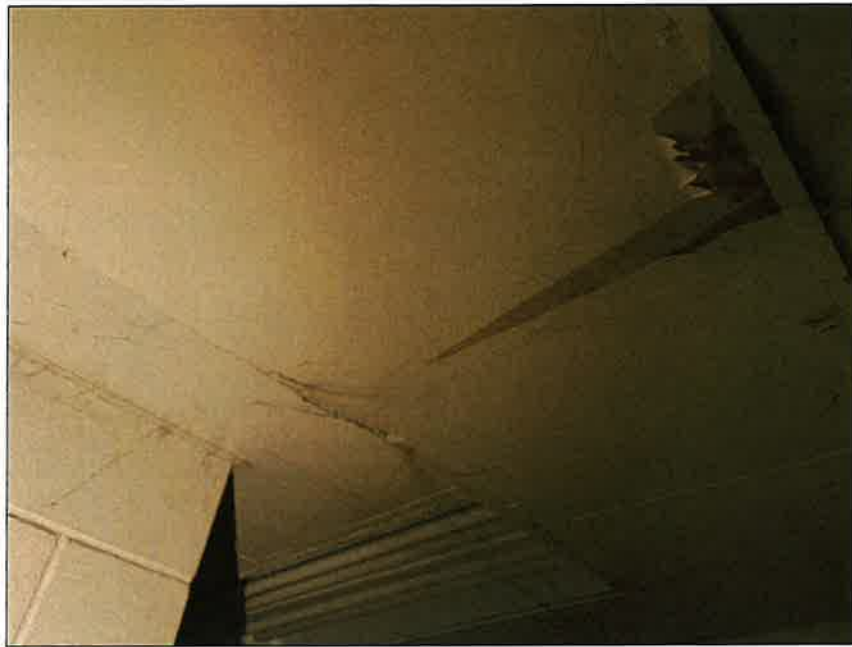
31 - Eastern Structure - Non-ACM 2' x 4' White Sanitary Ceiling Tile (CTL2)

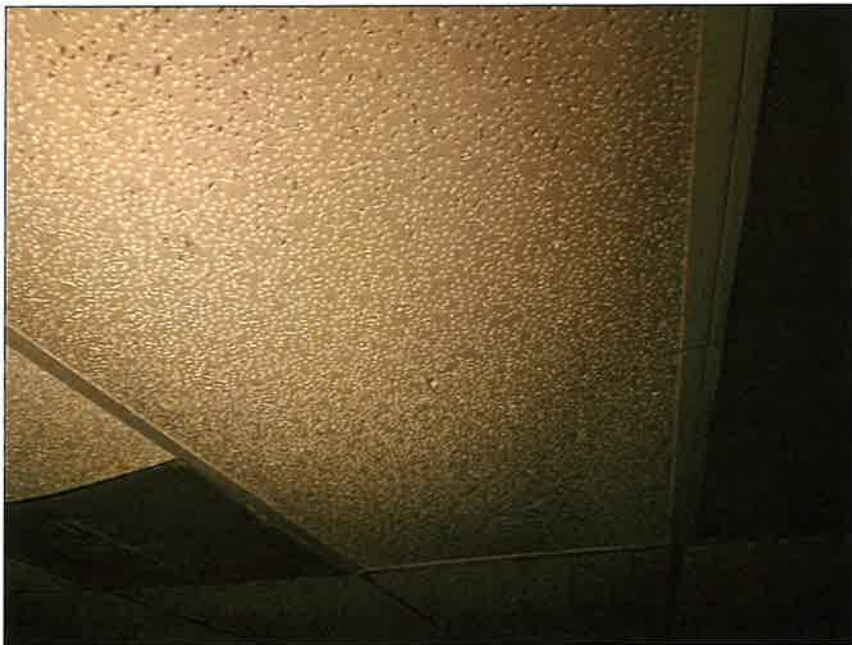
32 - Eastern Structure - Non-ACM 2' x 4' White Ceiling Tile (Small and Large Holes) (CTL3)

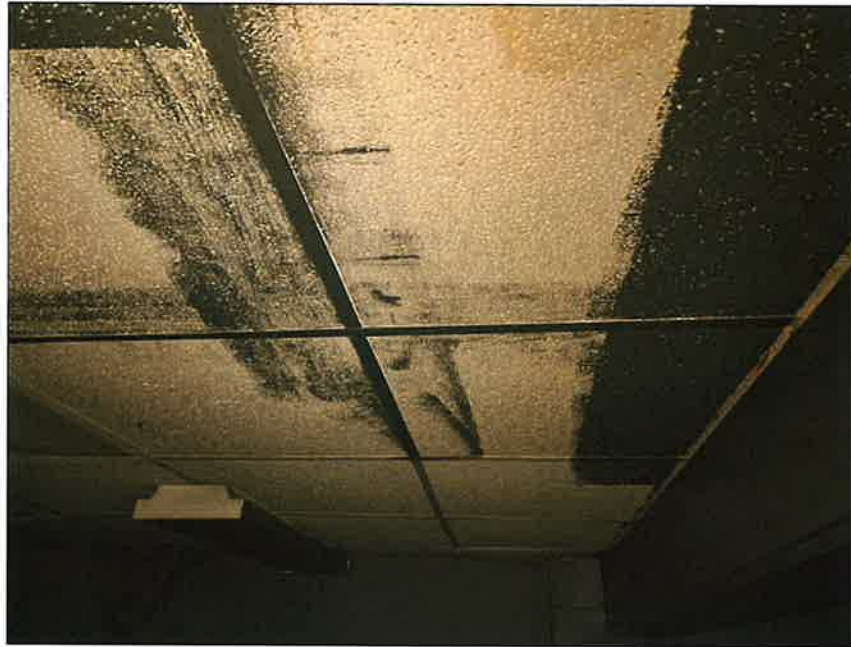
33 - Eastern Structure - Non-ACM 2' x 2' White/Grey Ceiling Tile (CTL4)

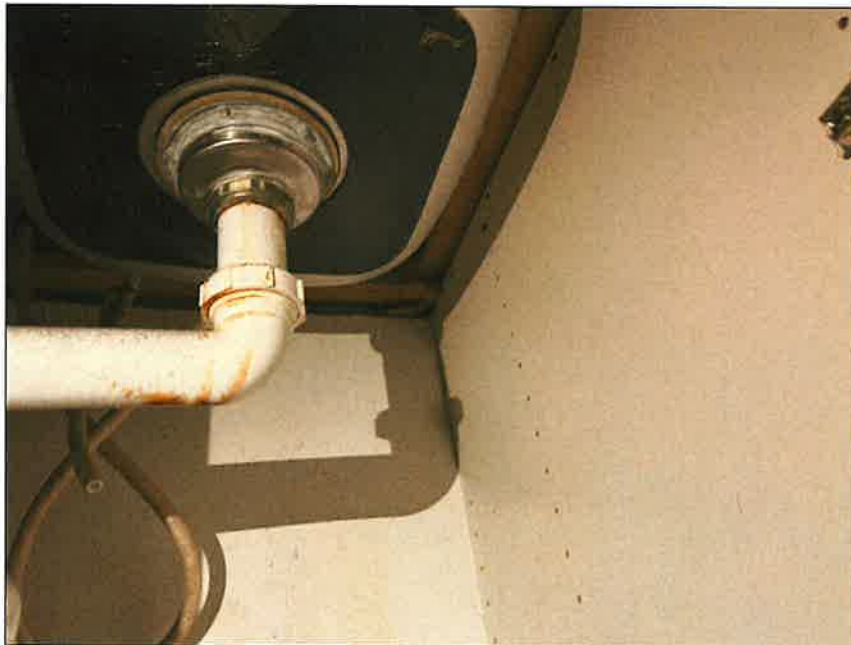
34 - Eastern Structure - Non-ACM Black Sink Underpad (SU1)

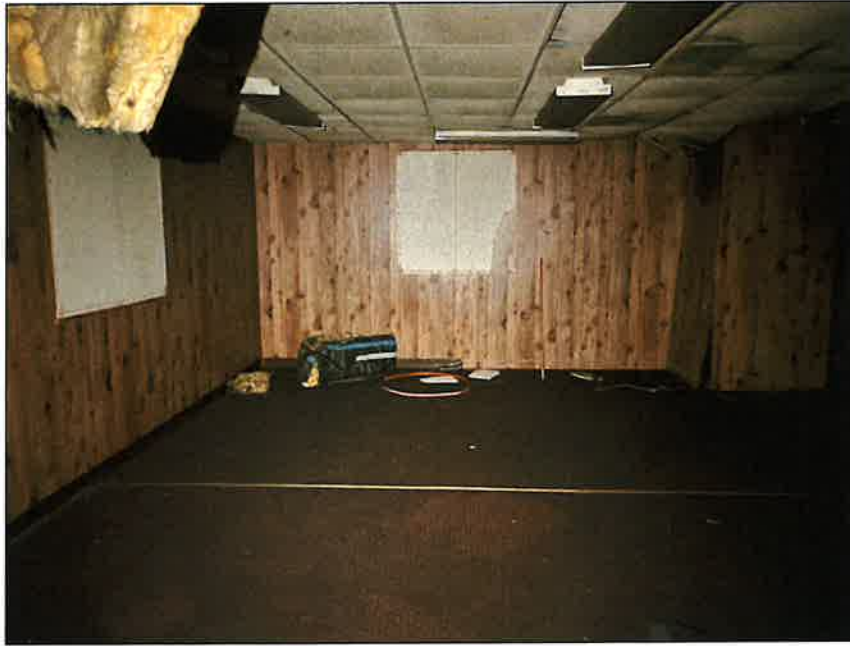
35 - Eastern Structure - Non-ACM 4" Brown Cove Base and Mastic (CB2)

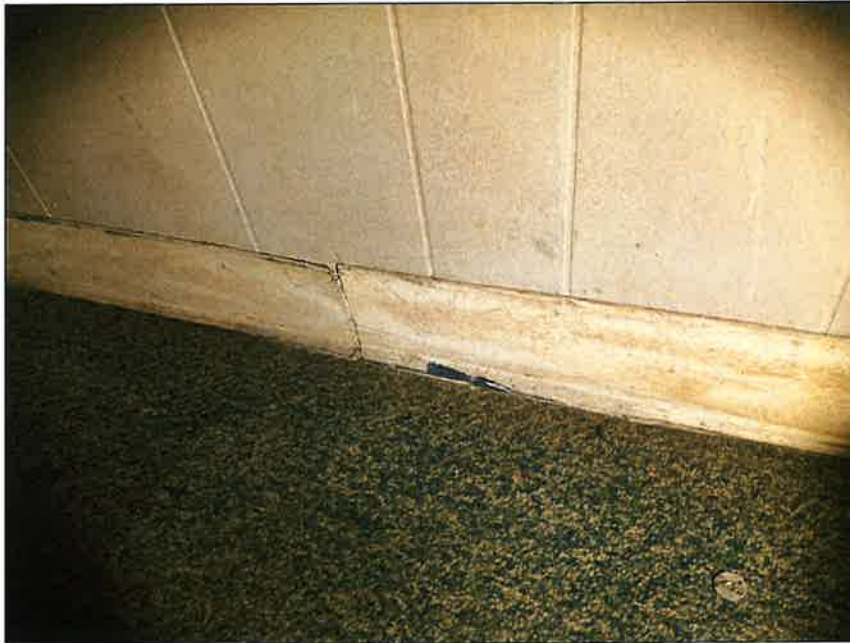
36 - Eastern Structure - Non-ACM 4" White/Blue Cove Base and Mastic (CB1)

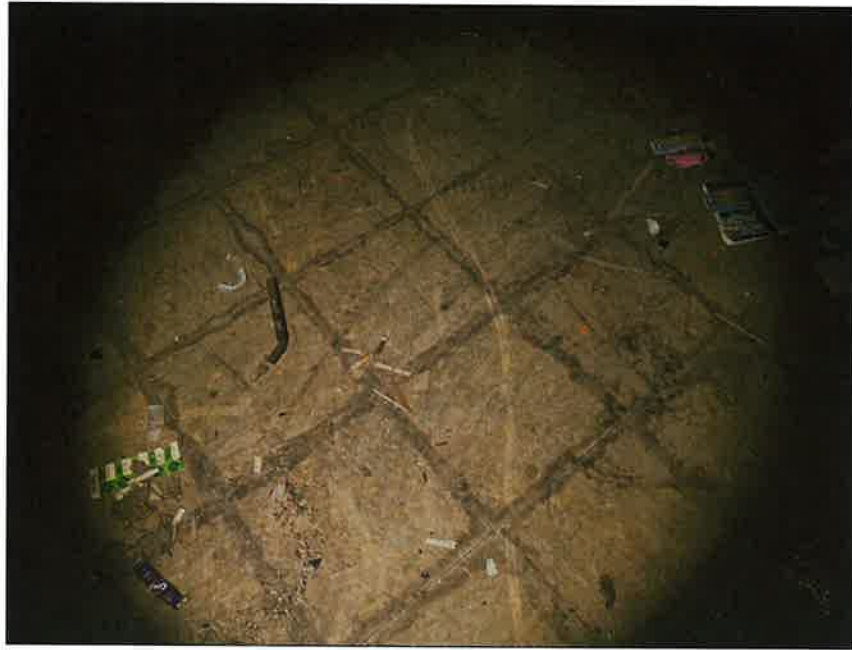
37 - Eastern Structure - ACM 12" x 12" Tan Floor Tile and ACM Black Mastic (FL1)

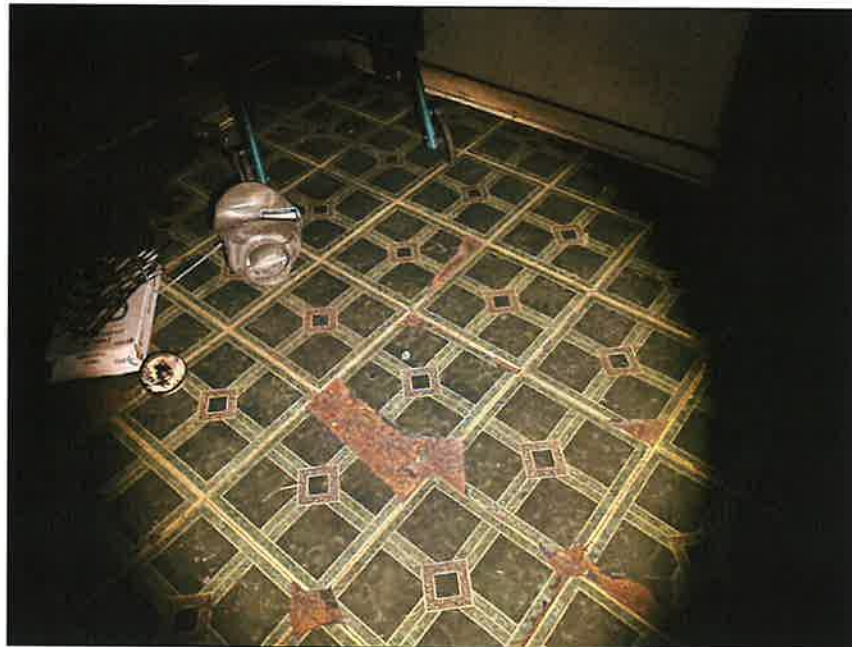
1. Evidence of black mastic was observed underneath tile. Black mastic associated with floor tiles was positive, therefore this material should be assumed to be positive.

38 - Eastern Structure - Non-ACM Vinyl Flooring, located in Floor 1 Southern Area Bathrooms
(however, ACM black mastic was observed underneath the materials)

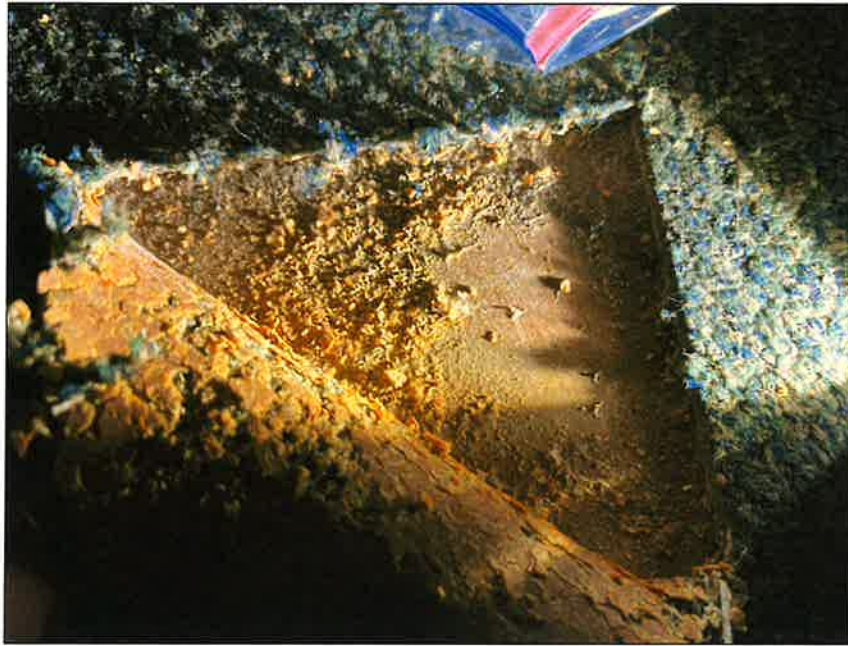
39 - Eastern Structure - Non-ACM Yellow Carpet Mastic (CM1)
