# ASBESTOS AND LEAD PAINT SURVEY

## LUMBERTON MAIN POST OFFICE LUMBERTON, MISSISSIPPI 39455-9998

ASBESTOS SURVEY OF  
LUMBERTON POST OFFICE  
7877 U.S. HIGHWAY 11  
LUMBERTON, MISSISSIPPI  
39455-9998

Subject: Report of Survey for Asbestos-Containing Materials  
Lumberton Post Office, Lumberton, Mississippi  
Contract 475450-94-B-0320, USPS Work Order 13.00  
LAW Project 589-0869502/1030053905

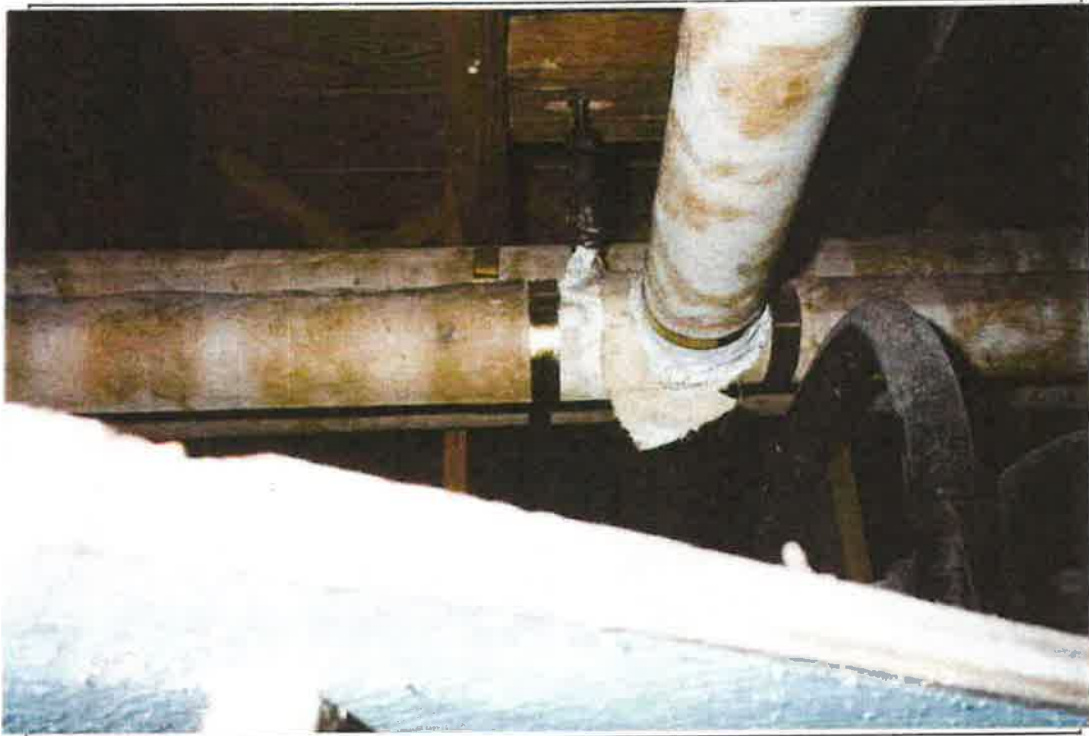
The asbestos-containing pipe insulation and pipe fitting insulation was observed to be in fair to good condition and was determined to be friable. This material was found in the crawl space between floors, and was rated as having "low" accessibility and "low" exposure potential.

Asbestos-containing pipe insulation.

We recommend that all asbestos-containing materials identified at the site be included in an Operations and Maintenance (O&M) Program for in-place management. If these materials are likely to be disturbed during renovation activities, they should be properly abated by a qualified contractor under a strict specification prior to the renovation activities.

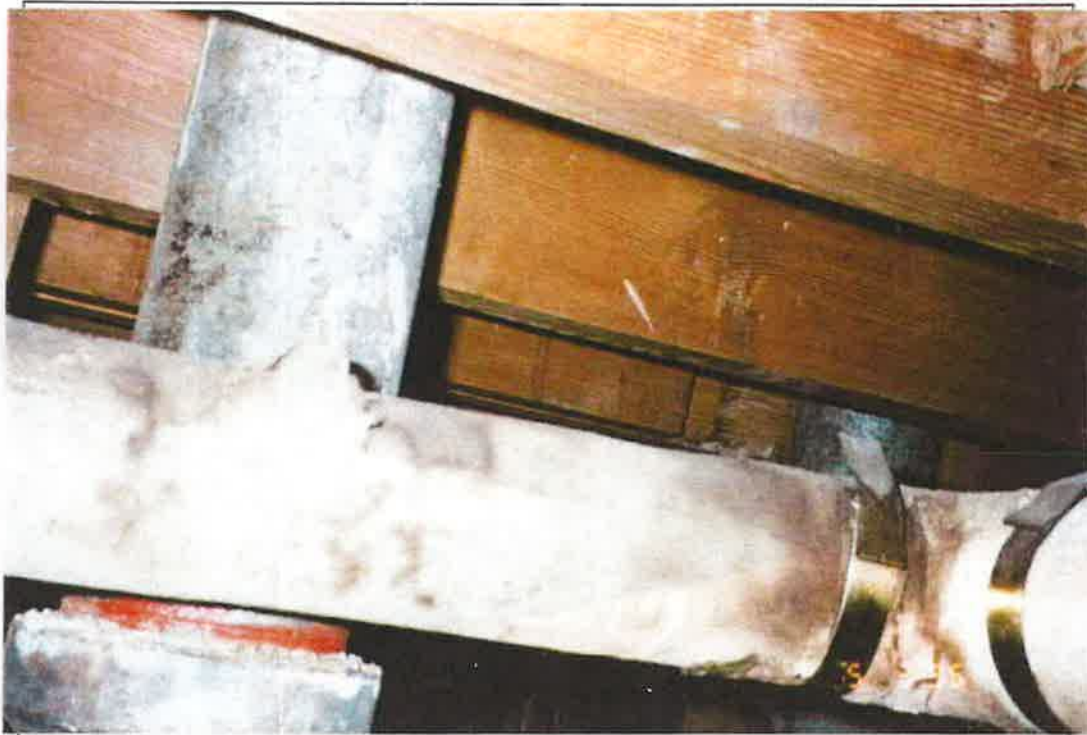
Asbestos-containing pipe fitting insulation.

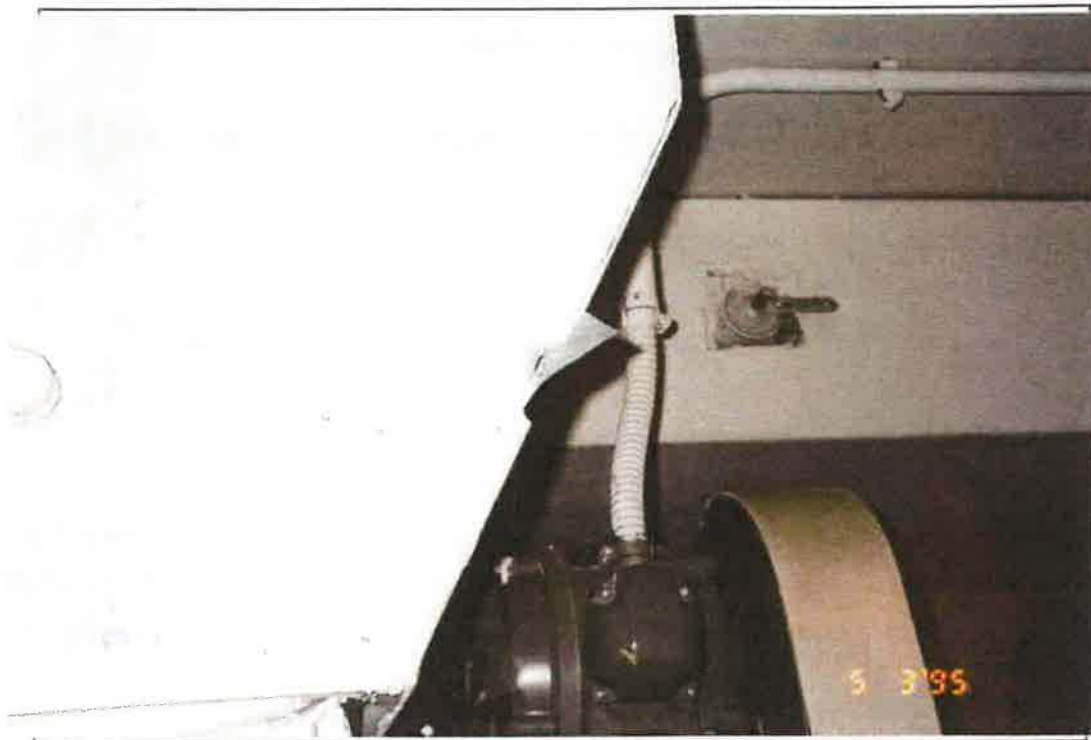
The asbestos-containing insulation on the HVAC unit was observed to be in fair to good condition and was determined to be friable. This material was found in the 2nd floor mechanical room, and was rated as having "medium" accessibility and "low" exposure potential.

Asbestos-containing HVAC insulation.

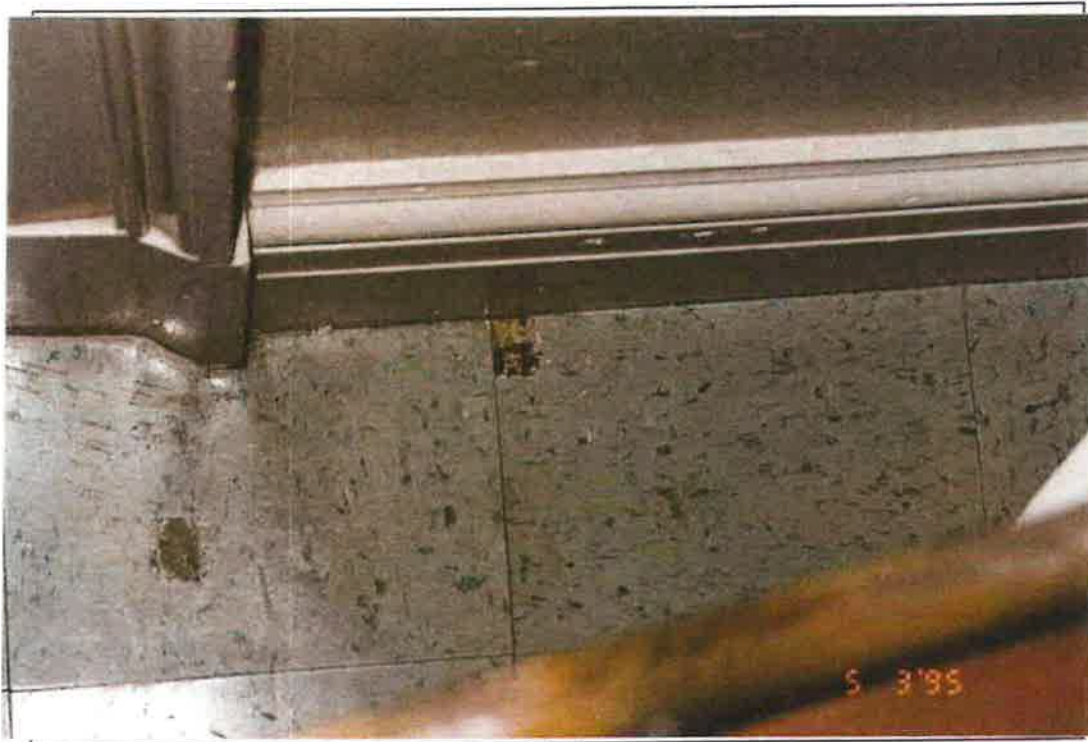
The white 9 by 9 inch floor tiles and associated mastics identified as asbestos-containing were found to be in fair to good condition and were determined to be nonfriable. This material was limited to the Postmaster's office, was rated as having "medium" accessibility and "low" exposure potential.

Asbestos-containing white 9 by 9 inch floor tile and associated mastic.

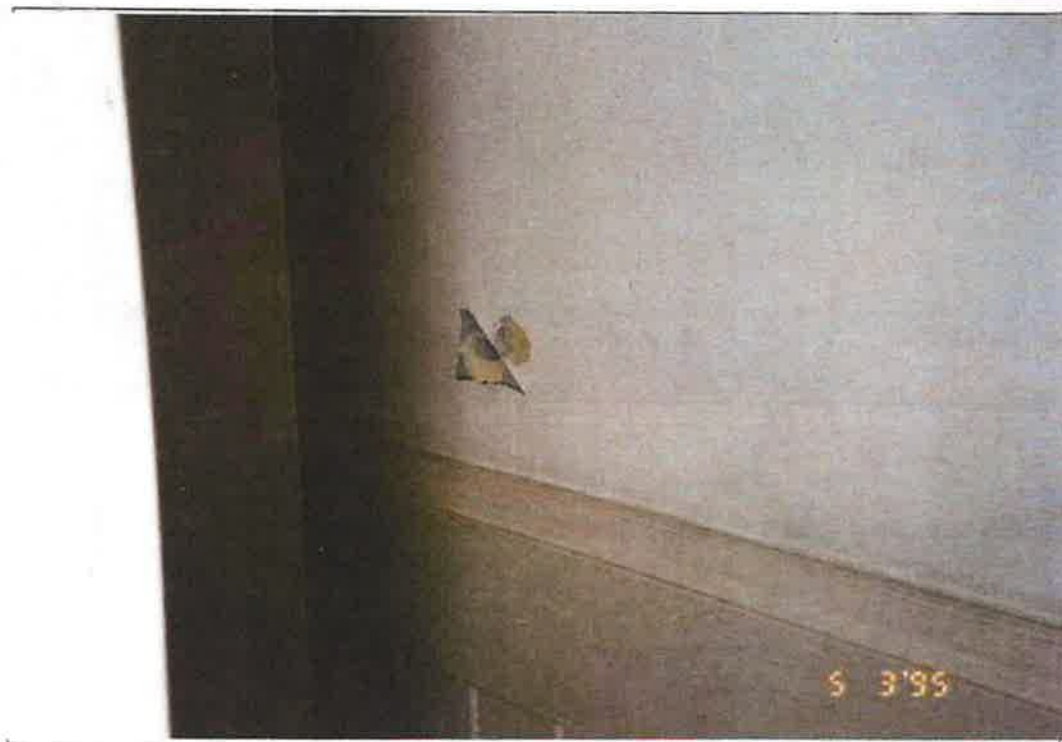
Non-ACM wall plaster.

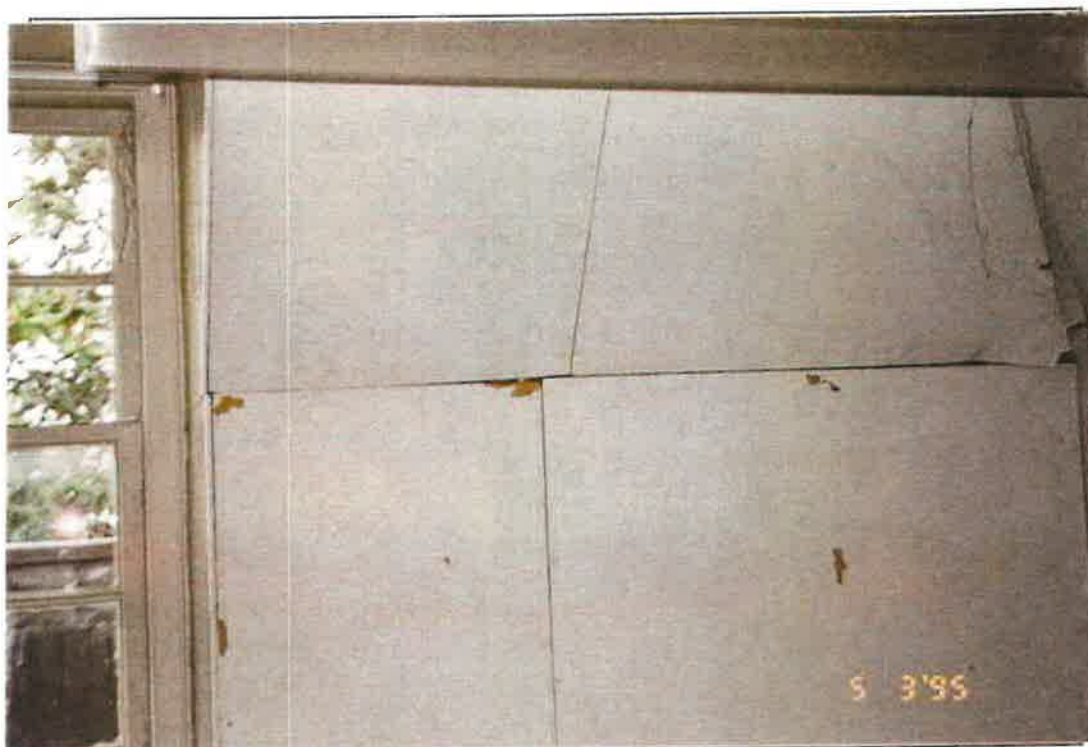
Non-ACM fibrous wall and ceiling panels.

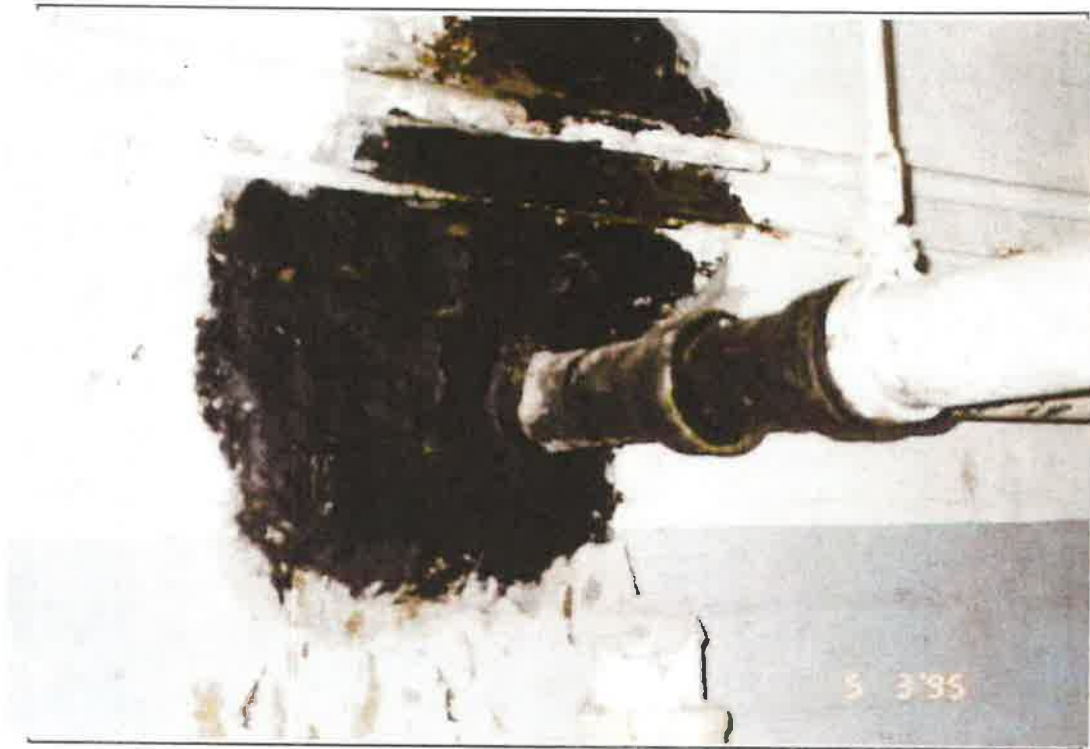
Non-ACM black mastic on piping.

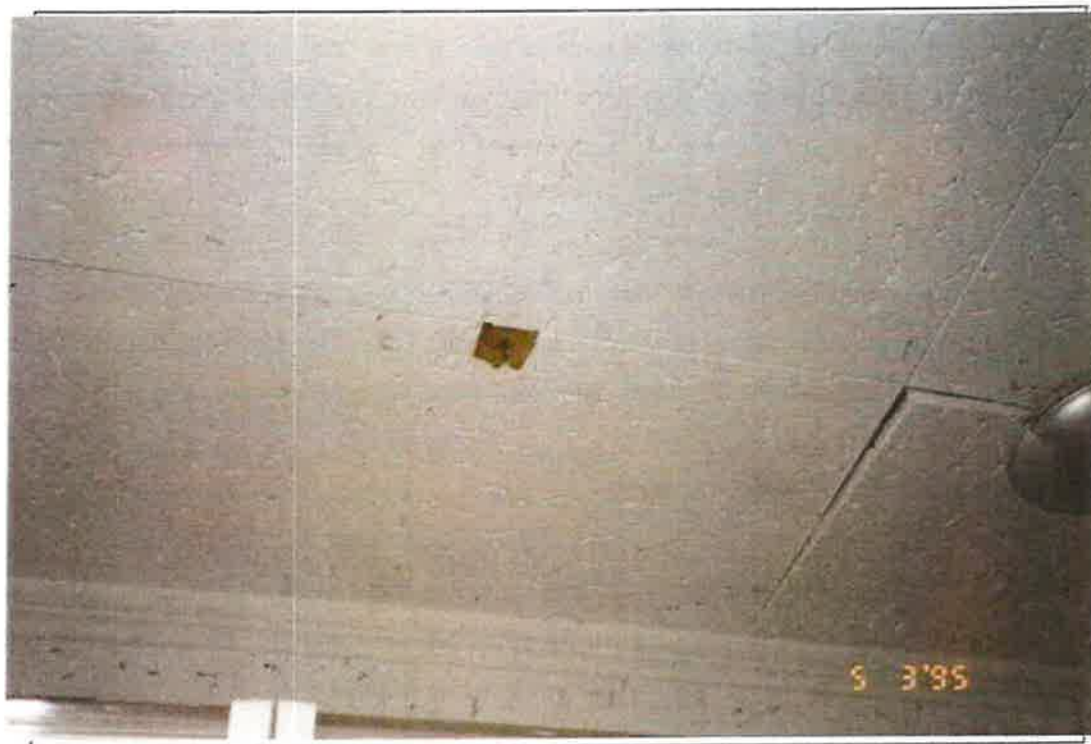
Non-ACM white 12 by 12 fissured acoustical ceiling tiles.
