# MISSISSIPPI ASBESTOS DEMOLITION/RENOVATION NOTIFICATION FORM

**ASBESTOS AND LEAD-BASED PAINT  
SURVEY AND ASSESSMENT**

**NORTHEAST MISSISSIPPI COMMUNITY COLLEGE  
WOOD HALL  
BOONEVILLE, MS**

**NOVEMBER 28, 2023  
PROJECT NO.: 24768.41 T001**

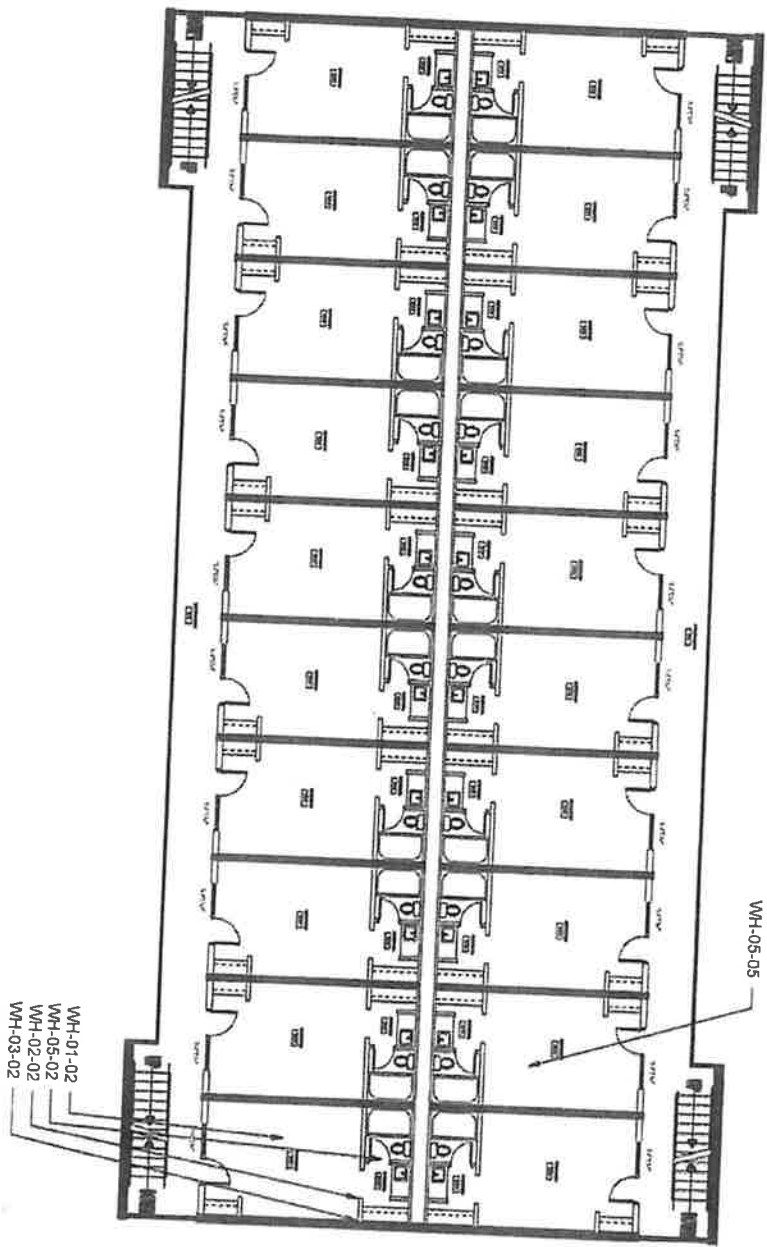
<p>2</p>	<p>             Northeast Mississippi Community College              Wood Hall              Second Floor              Booneville, Mississippi           </p>		<p>PROJECT # 2400000000</p>	<p>DATE 10/20/2003</p>
			<p>OWNER</p>	<p>CREATED BY</p>

WH-01-02  
 WH-05-02  
 WH-02-02  
 WH-03-02

WH-05-05
