**PRE-DEMOLITION ASSESSMENT REPORT
PRE-DEMOLITION SURVEYS AT
ARMED FORCES RESERVE CENTER,
JACKSON, MISSISSIPPI**

Contract No.: W912DY23P0033

DRAFT – July 26, 2024

**ARMY RESERVE DEMOLITION - ASBESTOS INSPECTION
180 COMMERCIAL AVENUE
JACKSON, MS 39209**

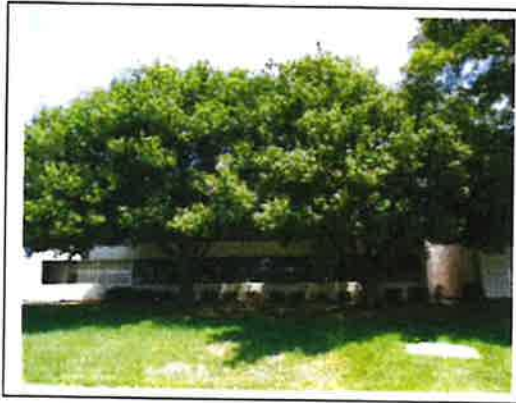
Building Exterior South

General Building Condition: Structural damage to front of building, which has started to separate from the structure; part of the concrete base has shifted, causing cracks in the floor. Damage to building interior caused by vandals removing metal components such as wiring and pipe.

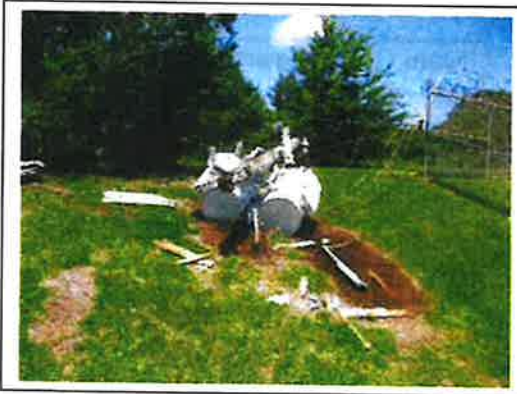
Transformers

Other: Brick chimney outside of building. Three formerly pole-mounted transformers were knocked down in a recent storm and are laying on the ground in the vicinity of the building.

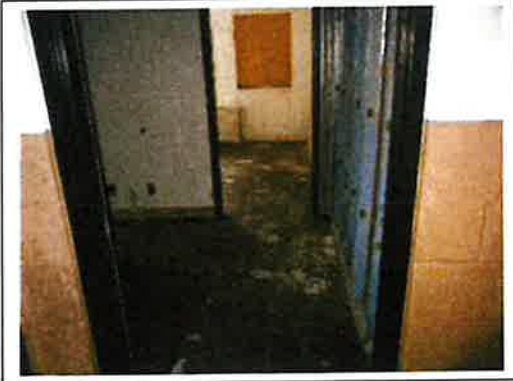
Building Interior Electrical Panels

Electrical Panels/Switch Gear/Fuse Boxes	5 have been stripped	7
	Emergency Lights with Battery(ies)		0
	Exit Signs: Illuminated		10
	Fire Extinguishers	Dry chemical	1
	HVAC Units: Small Units	On roof	2
	HVAC Units: Large Units	Ground mounted	3
	Tank: AST Use: Capacity:	Location	0
	Tank: UST/AST Use: Capacity:	Location	0
	Thermostats		1
	Water Coolers/Drinking Fountains		4
	Water Heaters	Size	0

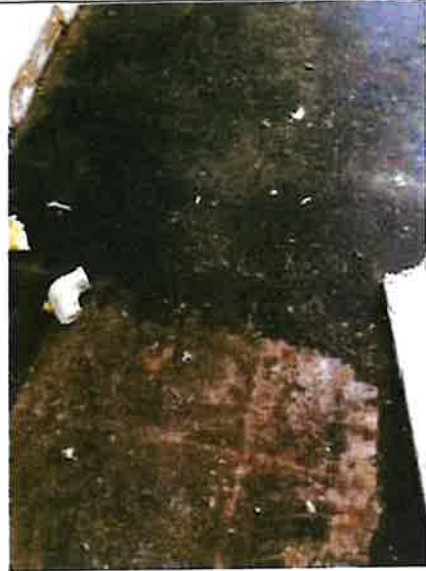
- Sample 03 – Black mastic residue (residual of a previous abatement) (estimated 16,000-18,000 sq. ft. of affected area)
Condition: Undamaged

Sample 03 – Black mastic – throughout the
building (some residual & some fully
applied)

I recommend that the floors be cleaned again by an MDEQ certified abatement contractor. There is residual mastic left from previous abatement and some areas of black mastic that don't appear to have been abated at all. If any of the identified asbestos materials are to be disturbed due to demolition and/ or renovation work performed, a MDEQ certified asbestos abatement contractor to properly abate the ACM.

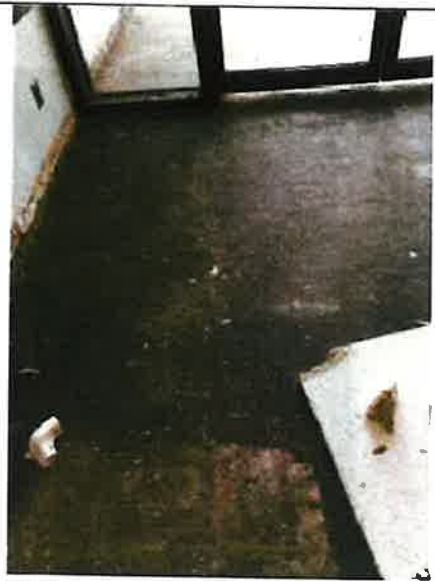
Sample 03 – Black mastic-front foyer

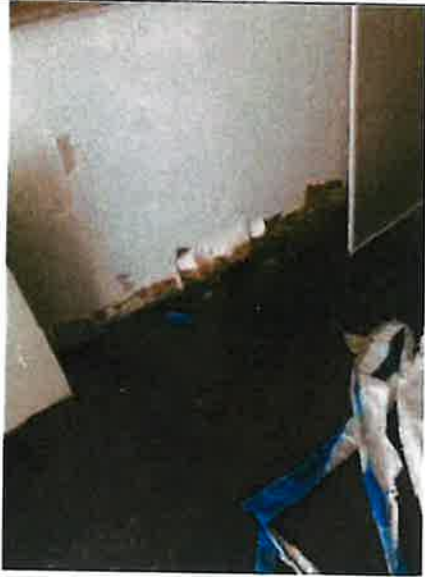
Black mastic – homogenous to 03
