MISSISSIPPI ASBESTOS DEMOLITION/RENOVATION NOTIFICATION FORM

Mold Investigation

Asbestos Survey

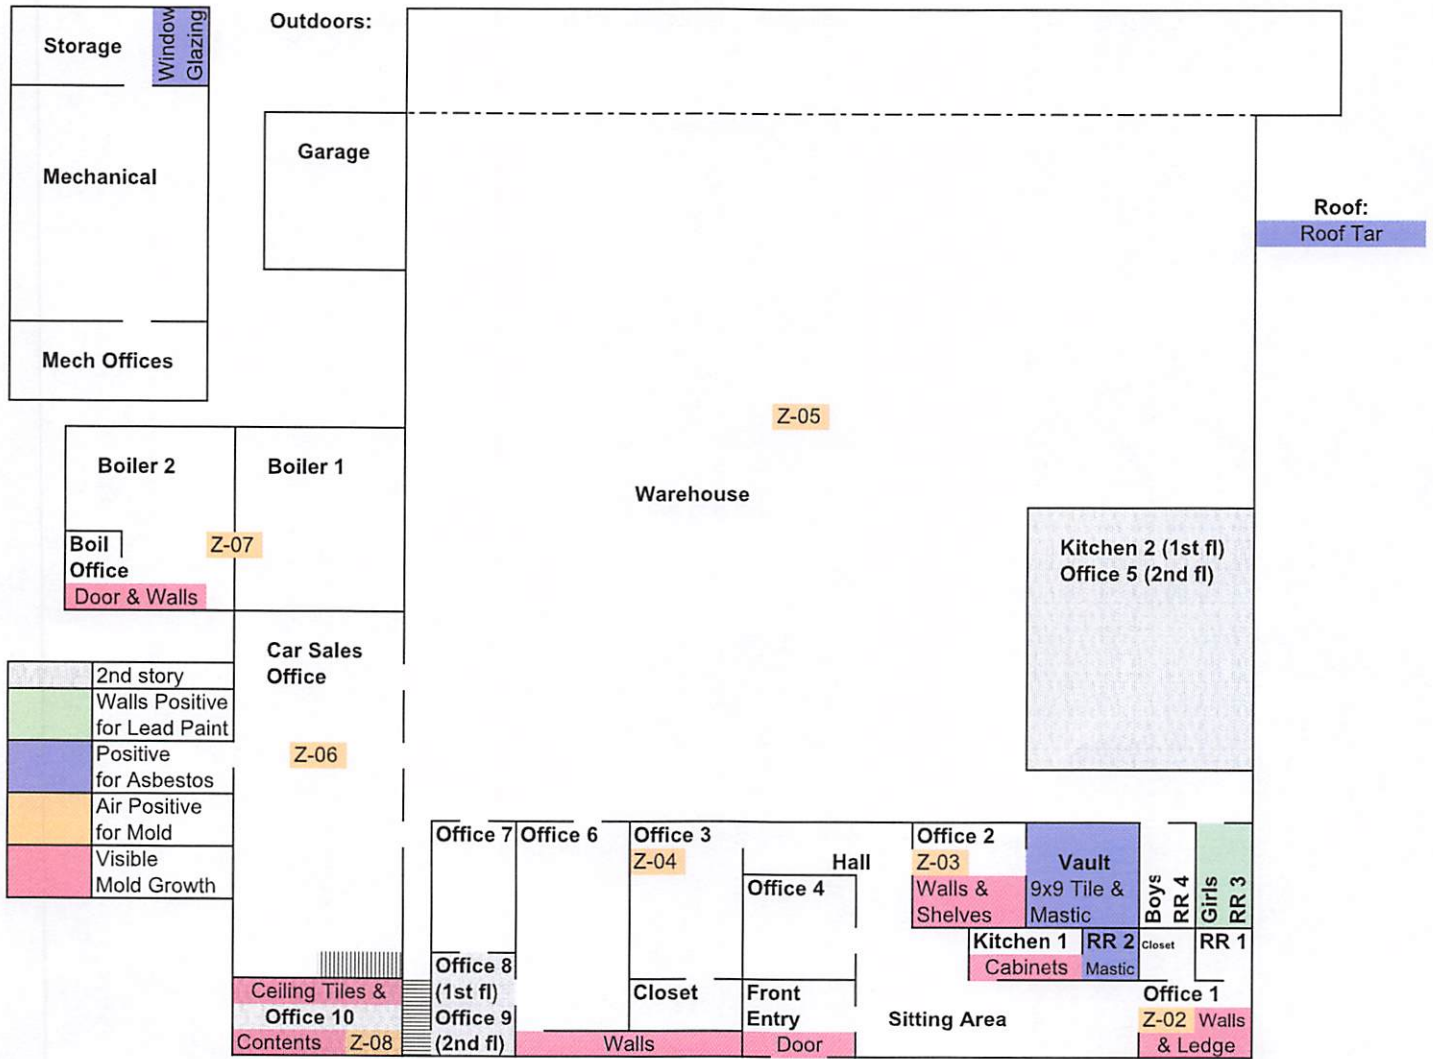
Samples Tested Positive

- Window Putty Glazing in the Mechanical Building
- 9x9 Brown Floor Tile and Black Mastic in the Vault
- Black Mastic under the Vinyl Floor Sheeting in Restroom #2
- Roof Tar

These materials can either be left in place or removed. Any actions taken to remove the identified asbestos containing materials should be done in such a manner as to keep the asbestos in a non-friable state. Once properly removed, the non-friable asbestos containing materials should be able to be disposed of in an asbestos landfill.
