**Storm Water Pollution Prevention
Plan**

**Neely Trucking & Excavating
Highway 49 Mine**

**Neely Trucking & Excavating Highway 49 Mine
Near the SE Corner of the Intersection of
Highway 49 & Maclean Road
Jackson, Hinds County, Mississippi**

FIGURES	Figure 1	Topographic Map and Site Plan
	Figure 2	Headwaters Wetlands Delineation
	Figure 3	Mining Maps

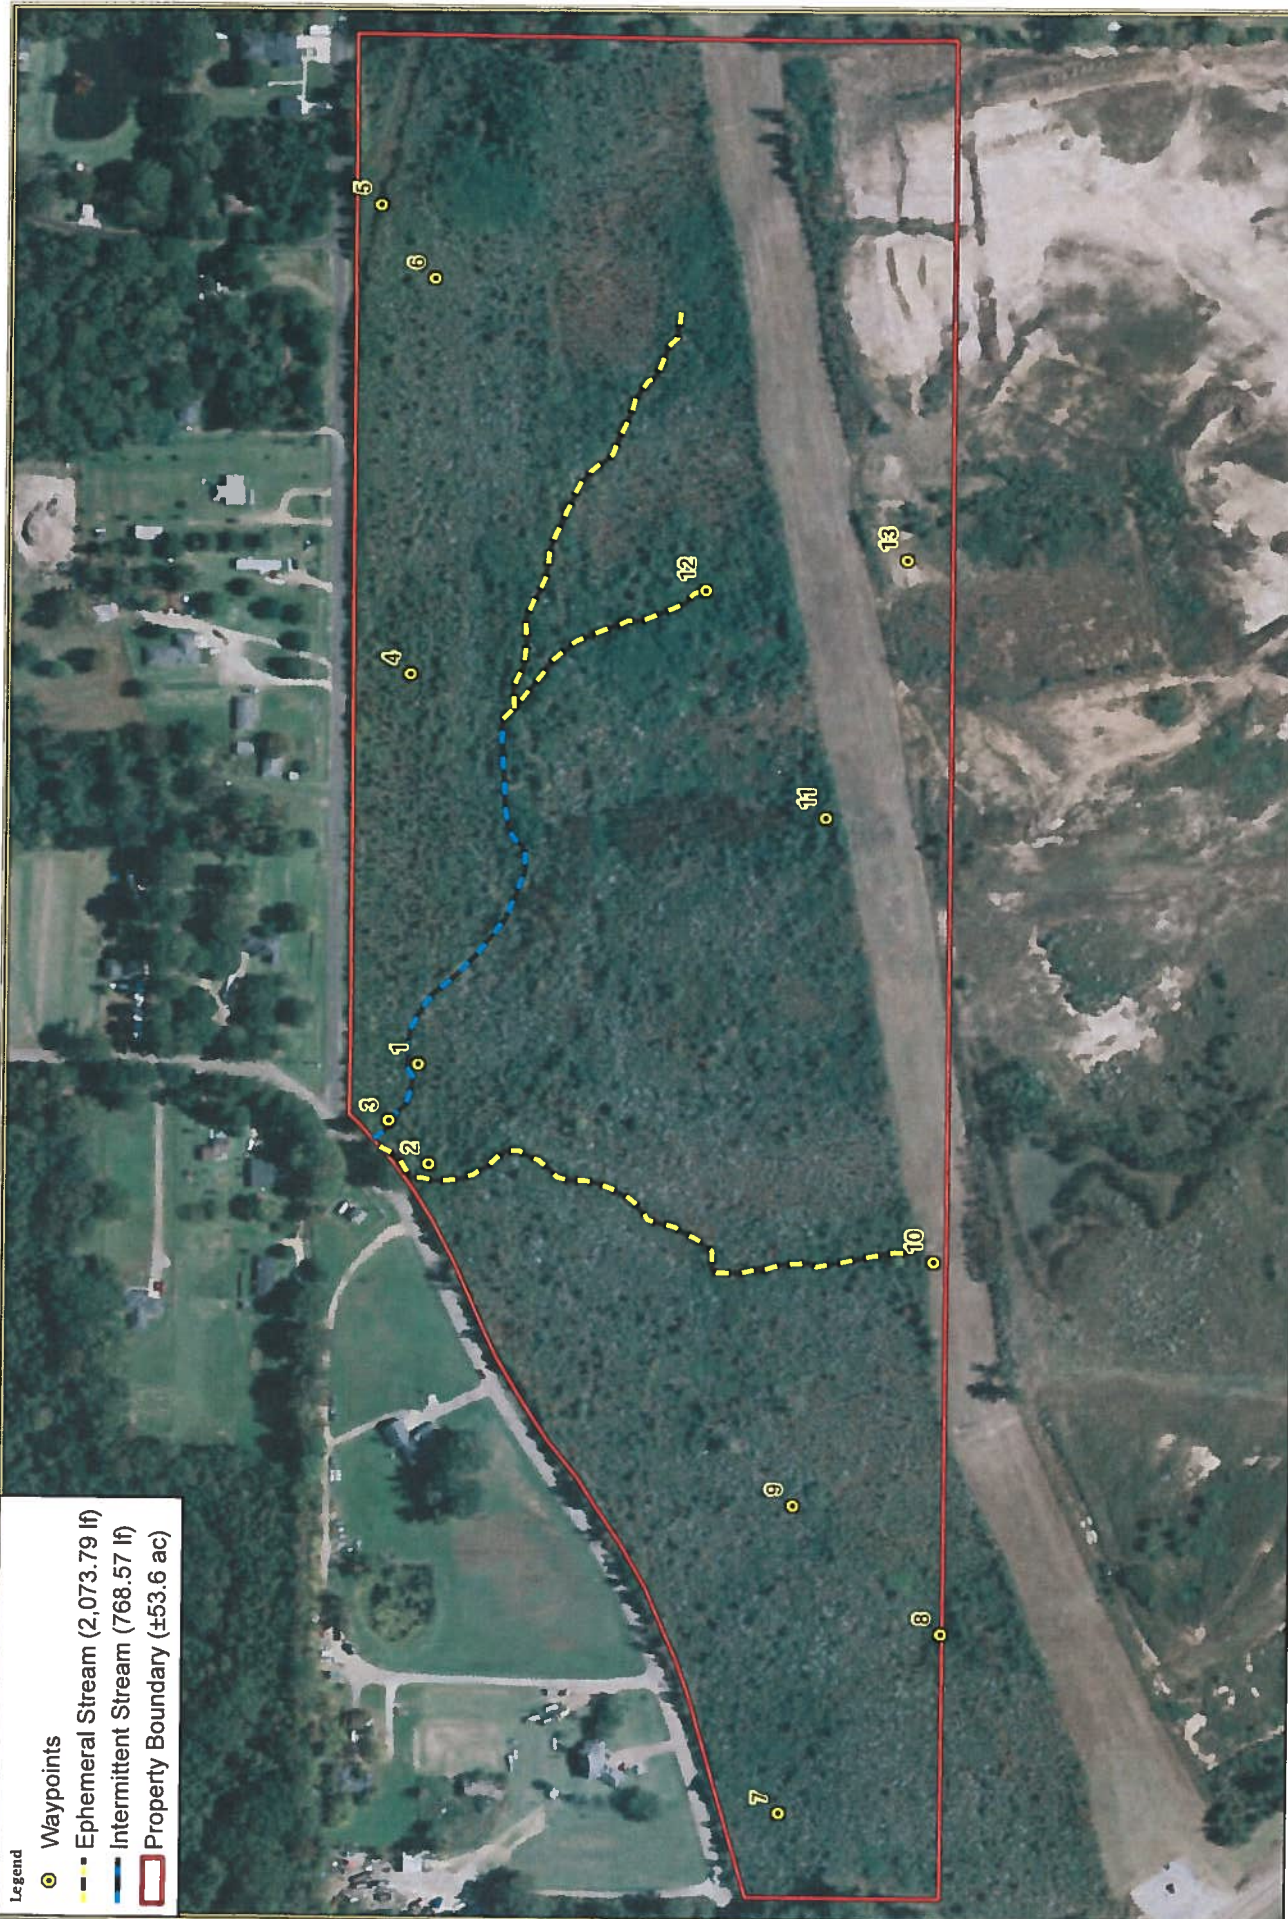
Neely Trucking Hwy 49 North Property Sec. 34 & 35, T7N, R1W Hinds County, Mississippi GPS/Wetland Location Map	
		Date Created: 6/3/2020 Created by: JDL
NAD 1983 StatePlane Mississippi West FIPS 2302 Feet USCS Pocahontas (MS) Quad Basemap

- Waypoints
- Ephemeral Stream (2,073.79 lf)
- Intermittent Stream (768.57 lf)
- Property Boundary (±53.6 ac)

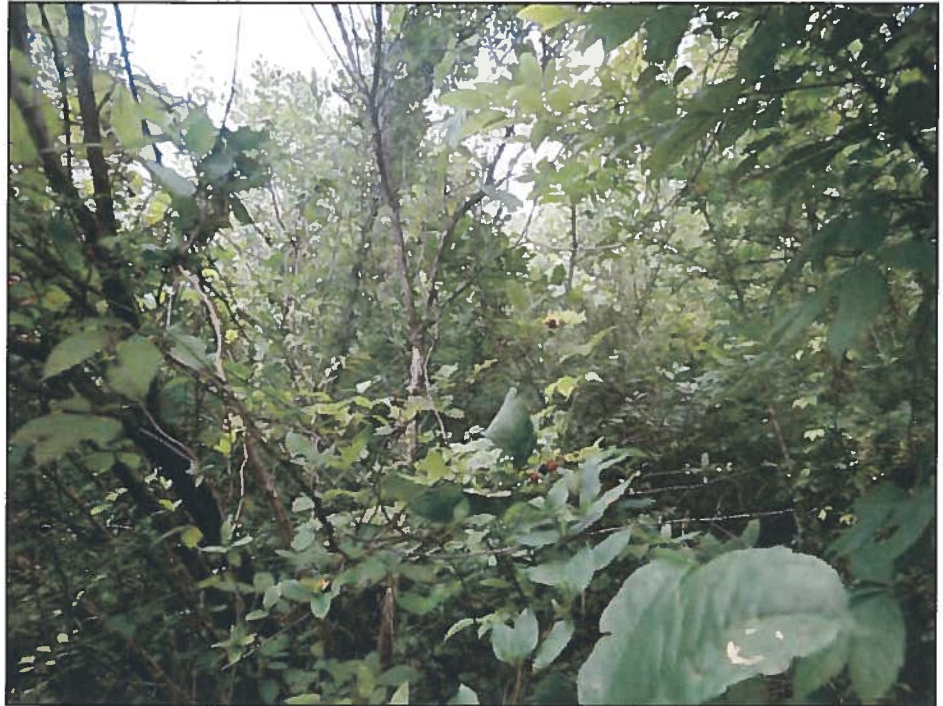
PHOTOGRAPH #1

View of the scrub-shrub habitat observed on the northern portion of the property.

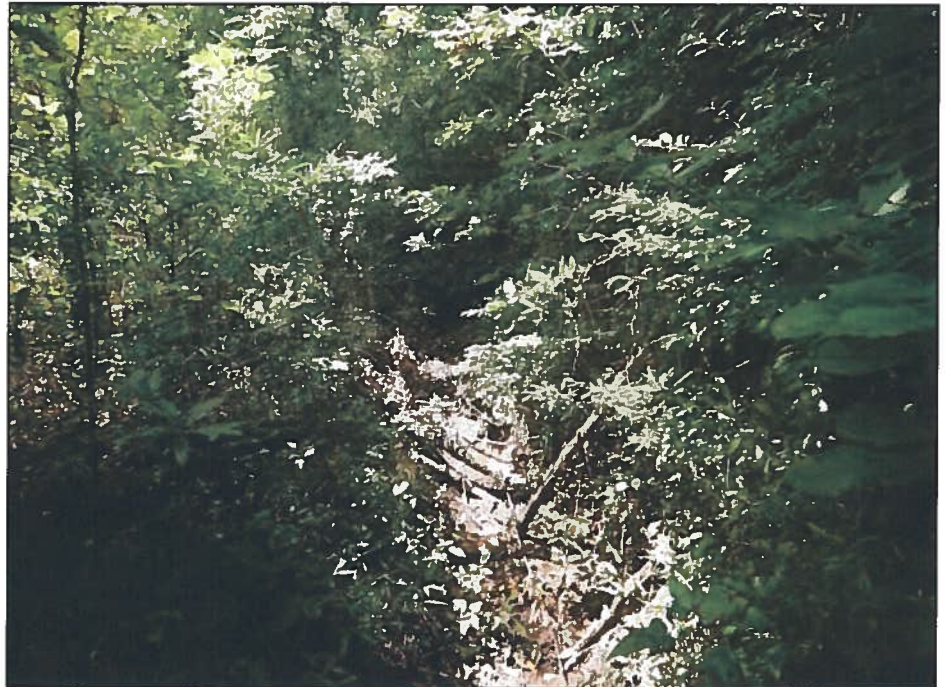
PHOTOGRAPH #2

View of an ephemeral stream channel on the northern portion of the property.

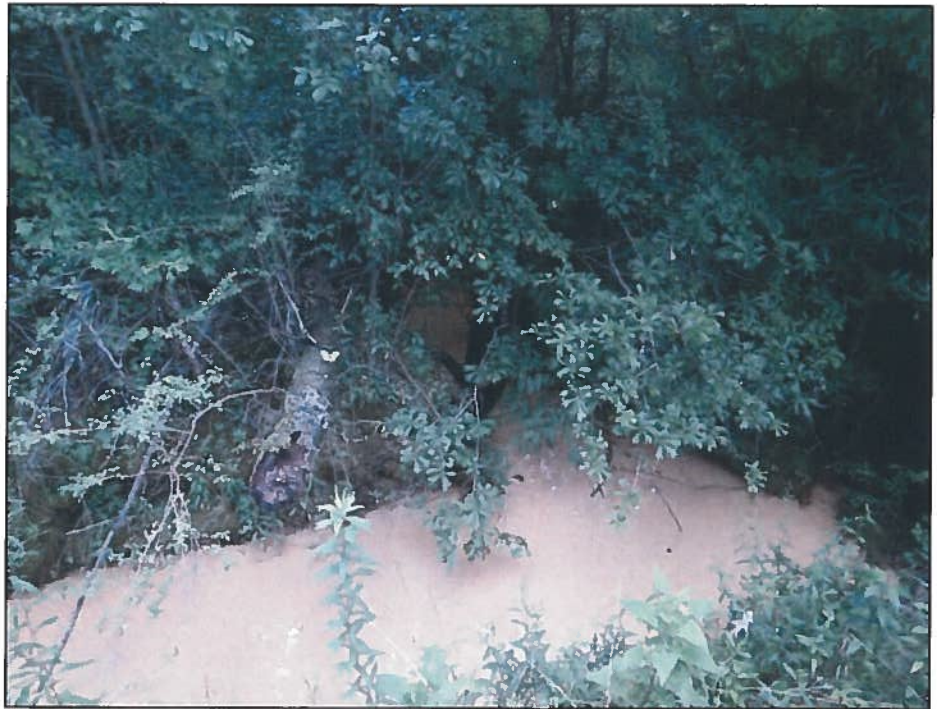
PHOTOGRAPH #3

View of the intermittent stream channel flowing northwest off the site.

One (1) segment of an intermittent stream channel was observed transecting the northern portion of the subject property. This stream reach may be characterized by a relatively small channel approximately three (3) feet wide and two (2) feet deep. More specifically, this stream channel exhibits seasonal or intermittent flows throughout the year. This stream reach lacks significant vegetative components within the channel. The top banks of the channel were revealed to be upland in nature. The presence of the intermittent stream reach identified within the limits of the subject property would be considered as an "other waters of the United States."

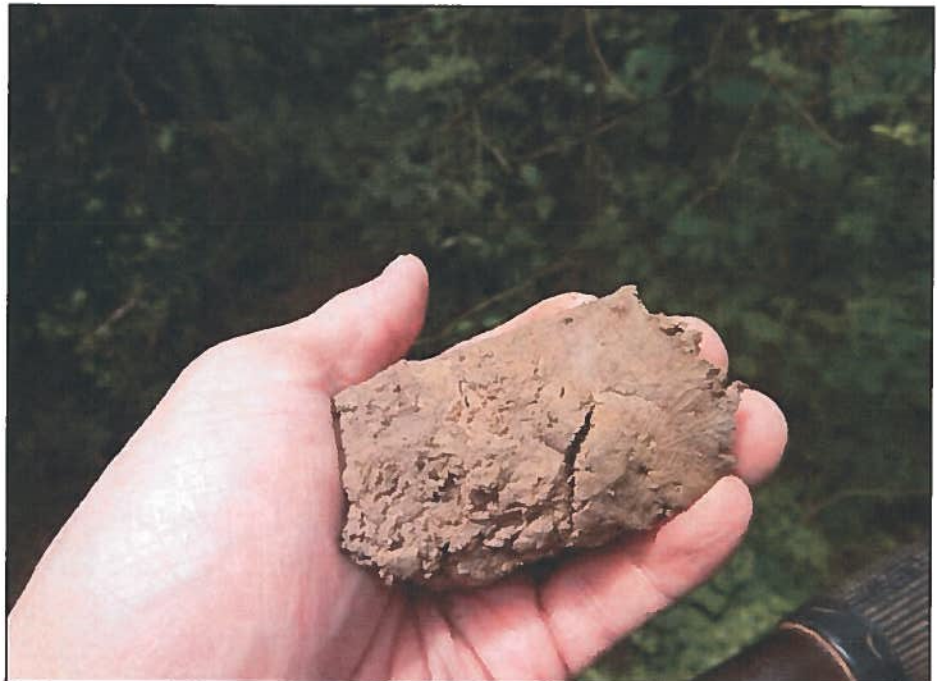
PHOTOGRAPH #4

View of the 5/4 upland soils encountered on the northern portion of the site.

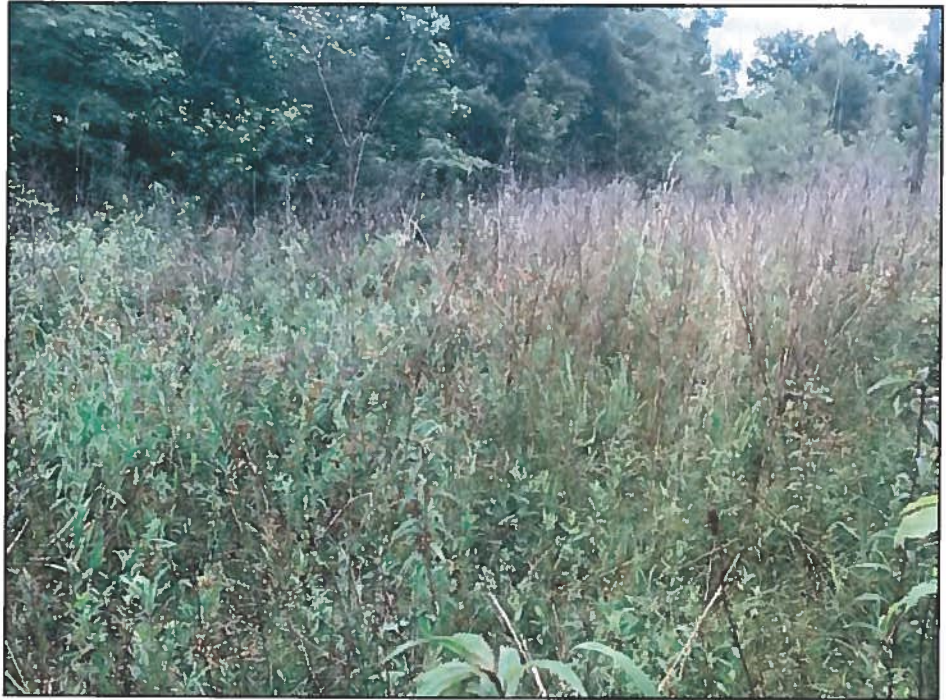
PHOTOGRAPH #5

View of the herbaceous upland observed on an electrical distribution line that transects the northeastern portion of the site.

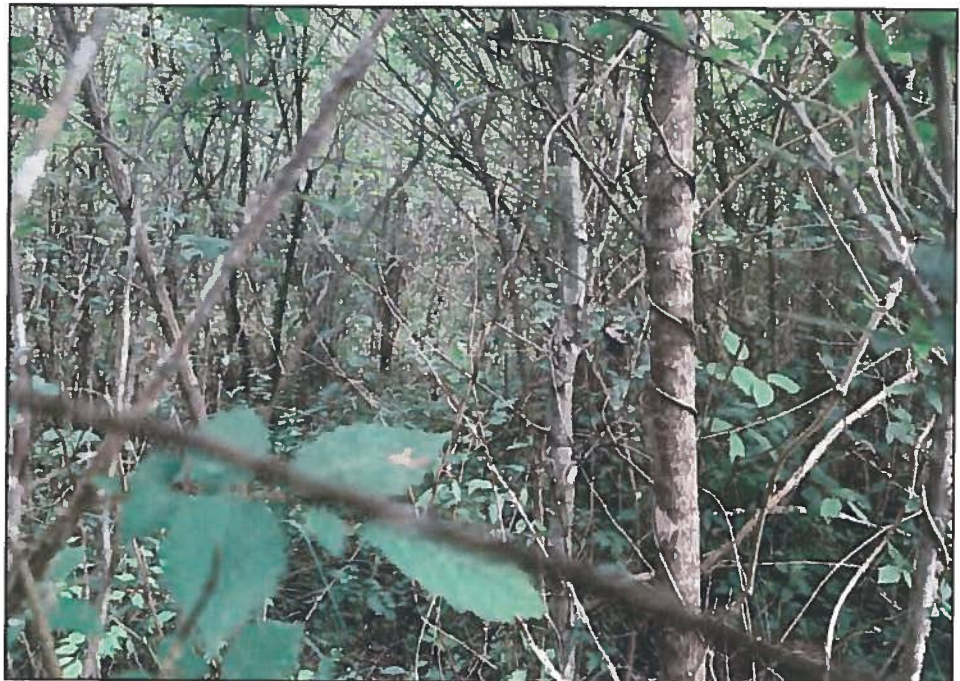
PHOTOGRAPH #6

View of the dense scrub-shrub upland habitat that occupies the majority of the site.

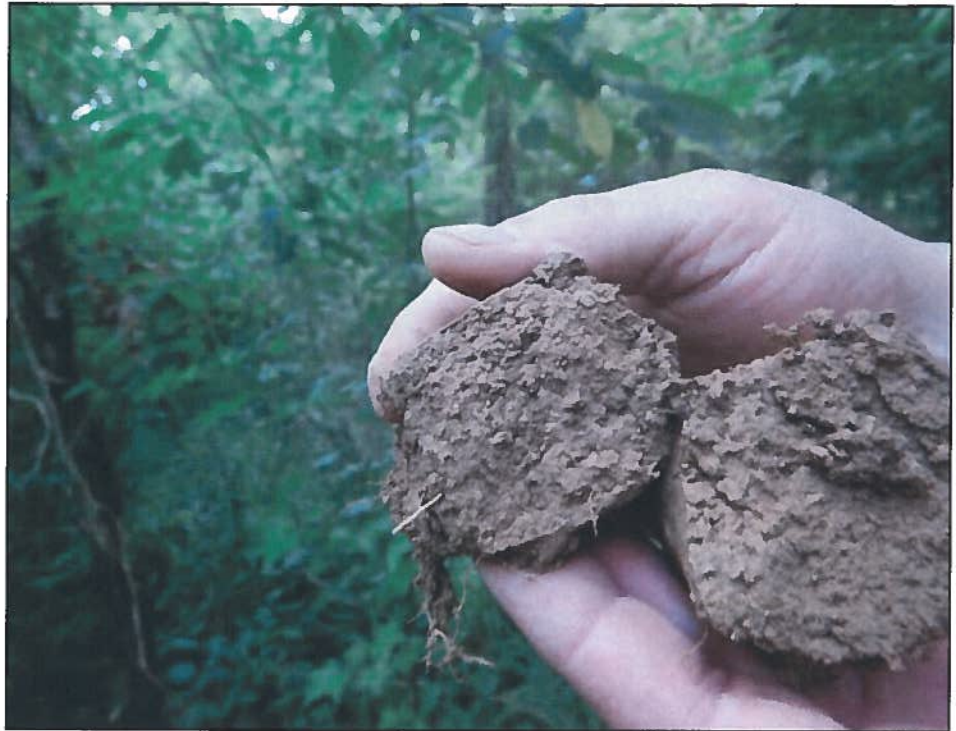
PHOTOGRAPH #7

View of a solid 10YR 5/3 upland soil observed at waypoint 7

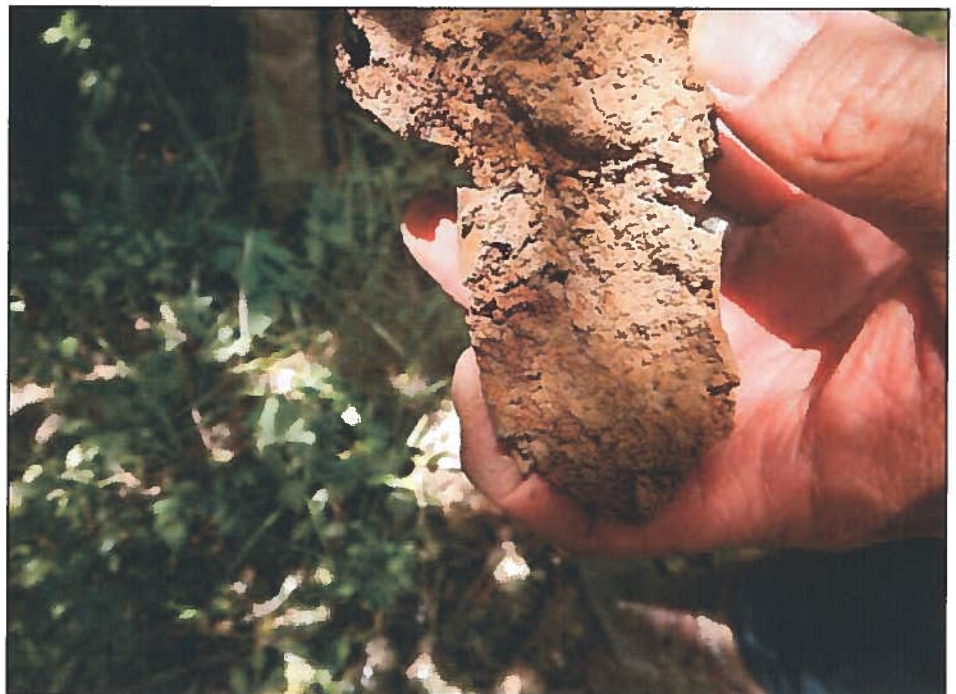
PHOTOGRAPH #8

View of an upland soil observed as a 10YR 5/3 soils with a 4/6 mottle. Most of the area has recently been cleared.

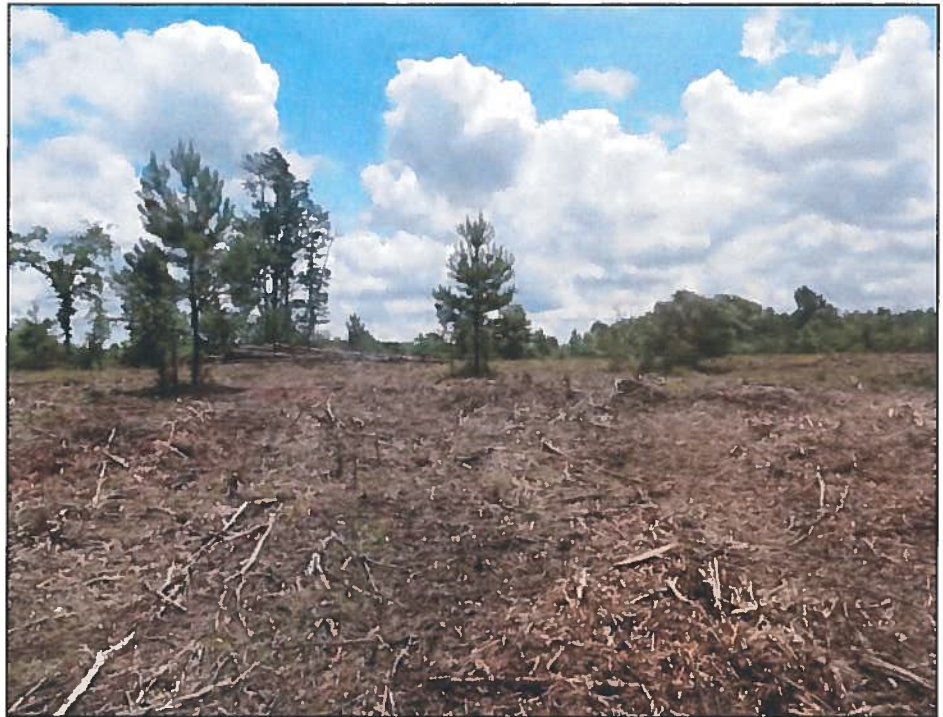
PHOTOGRAPH #9

View south of recently cleared area on the central and western portions of the property.

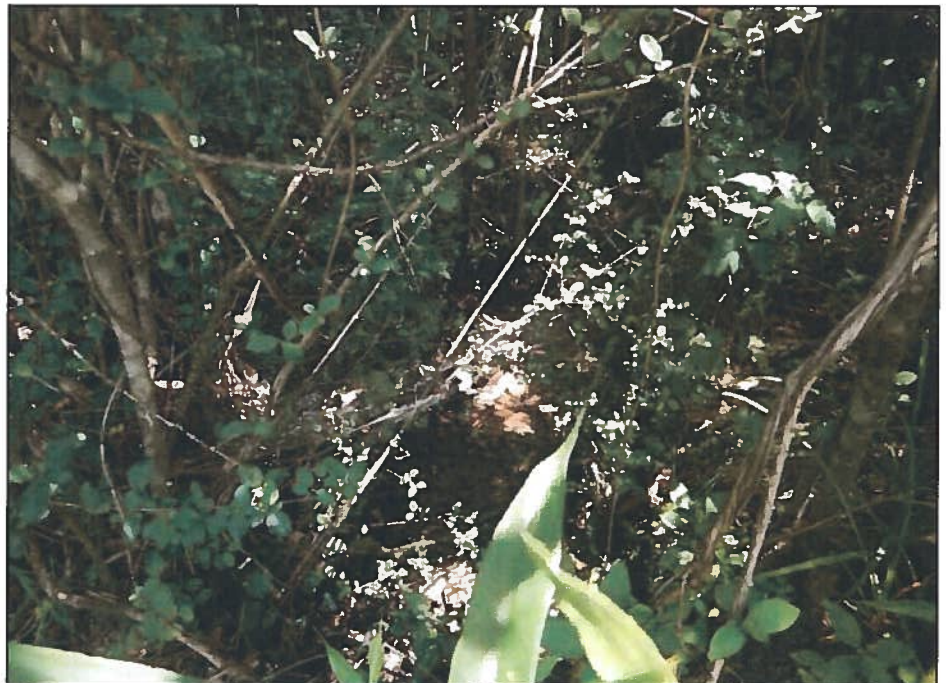
PHOTOGRAPH #10

View of an ephemeral channel and scrub-shrub upland habitat at waypoint 10.

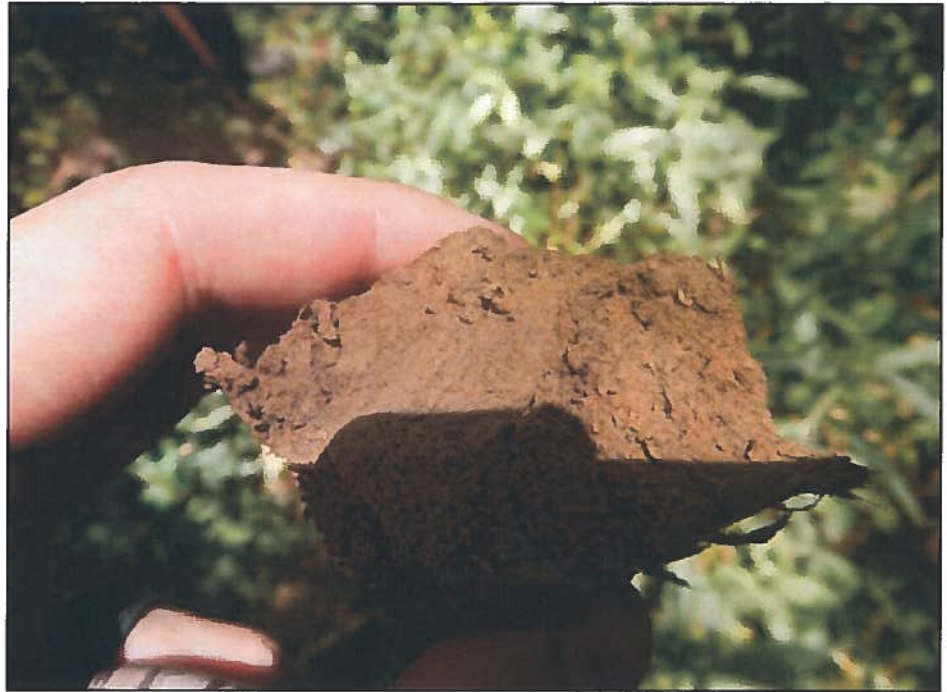
PHOTOGRAPH #11

View of the upland soils observed in a low area at waypoint 11.

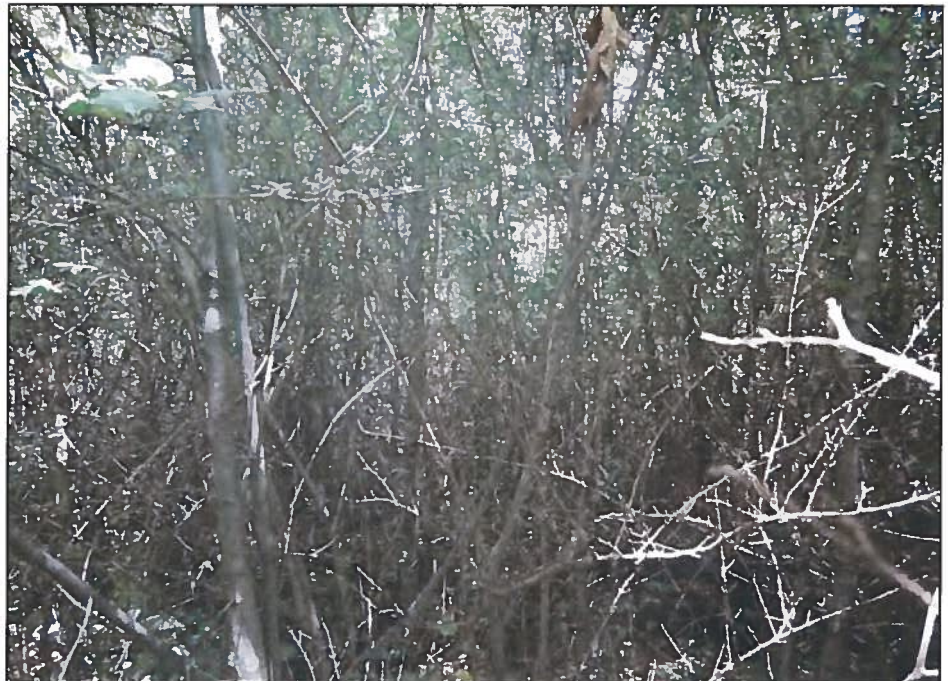
PHOTOGRAPH #12

View of the dense scrub-shrub habitat observed at waypoint 12

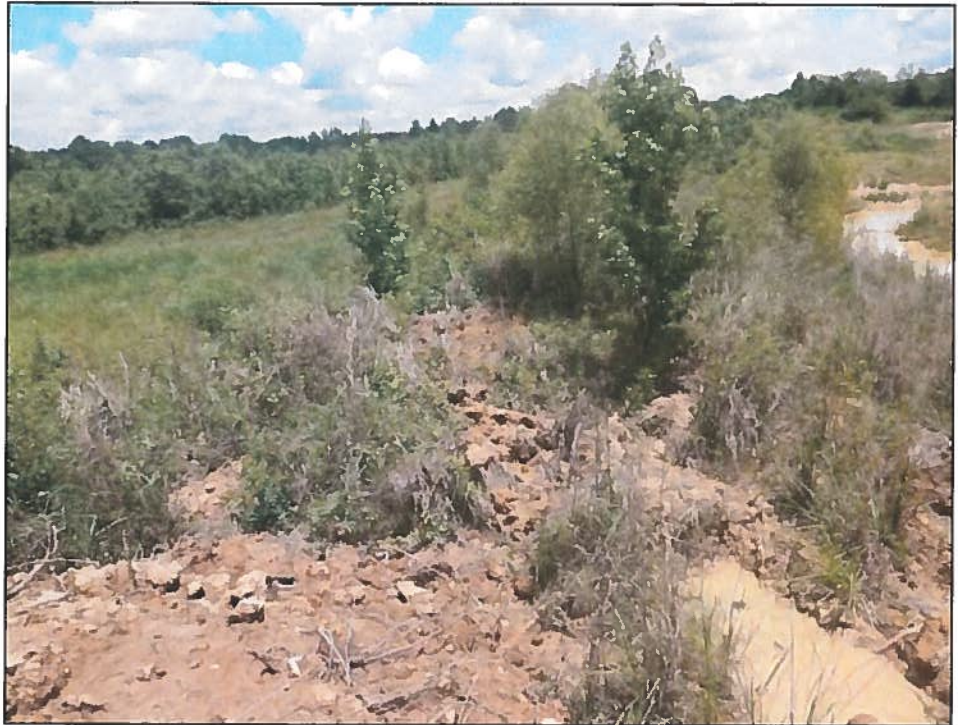
PHOTOGRAPH #13

View of an existing surface mine dirt pit. Area was being used as a detention basin.

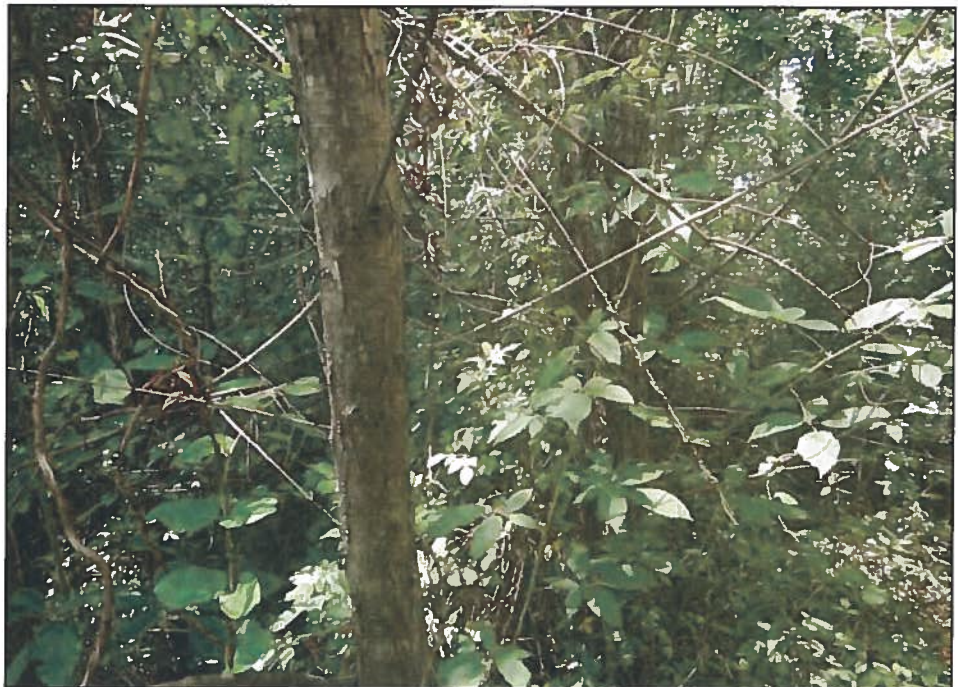
PHOTOGRAPH #14

View of the typical scrub-shrub habitat observed at waypoint 14.

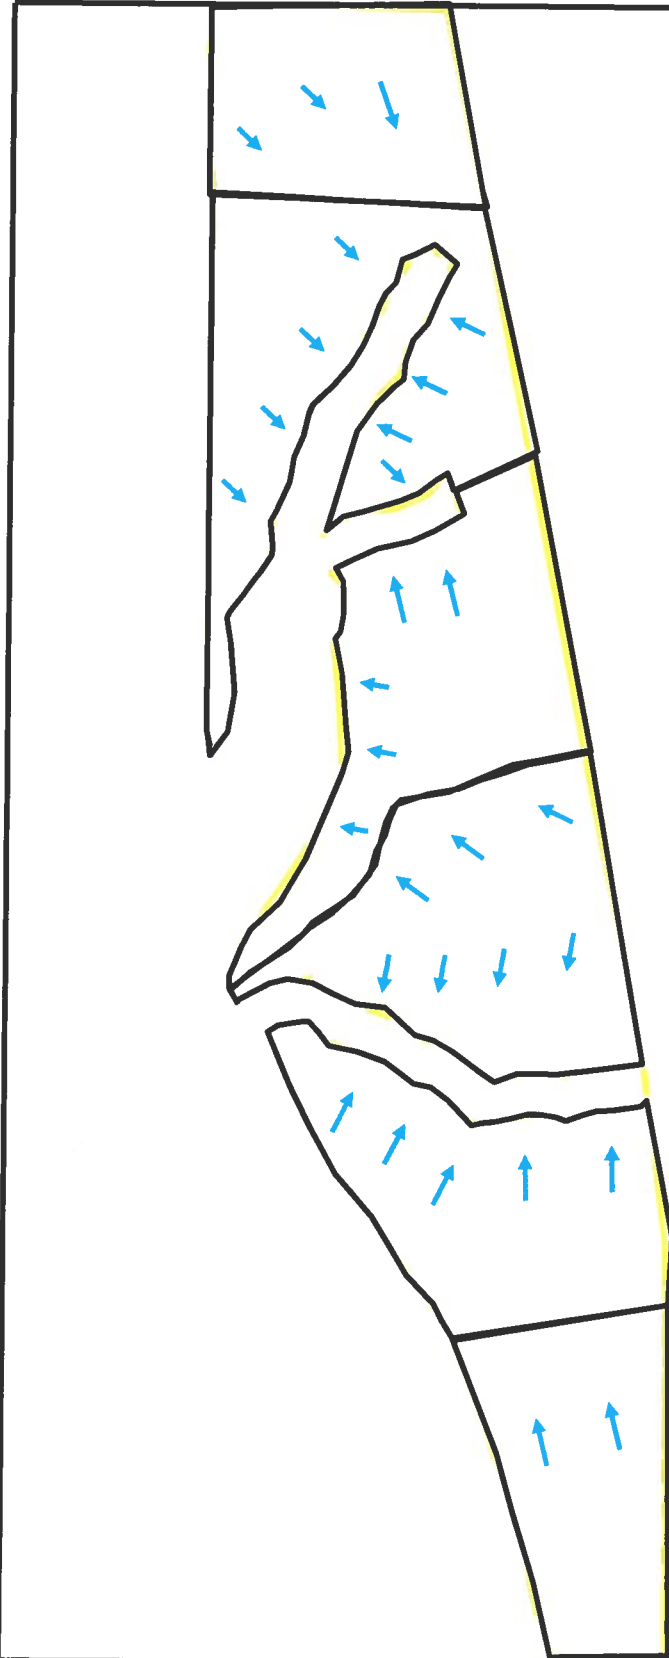
Drainage Pattern Map

4-Surface drainage will occur from natural contours of the site falling to the northeast, northwest, and southeast to an unnamed tributary of Bouge Chitto Creek.

Drainage across the preponderance of the subject property can be considered as moderate with natural drainage patterns found to be consistent with the available quadrangle maps. Drainage is conveyed generally to the north through natural

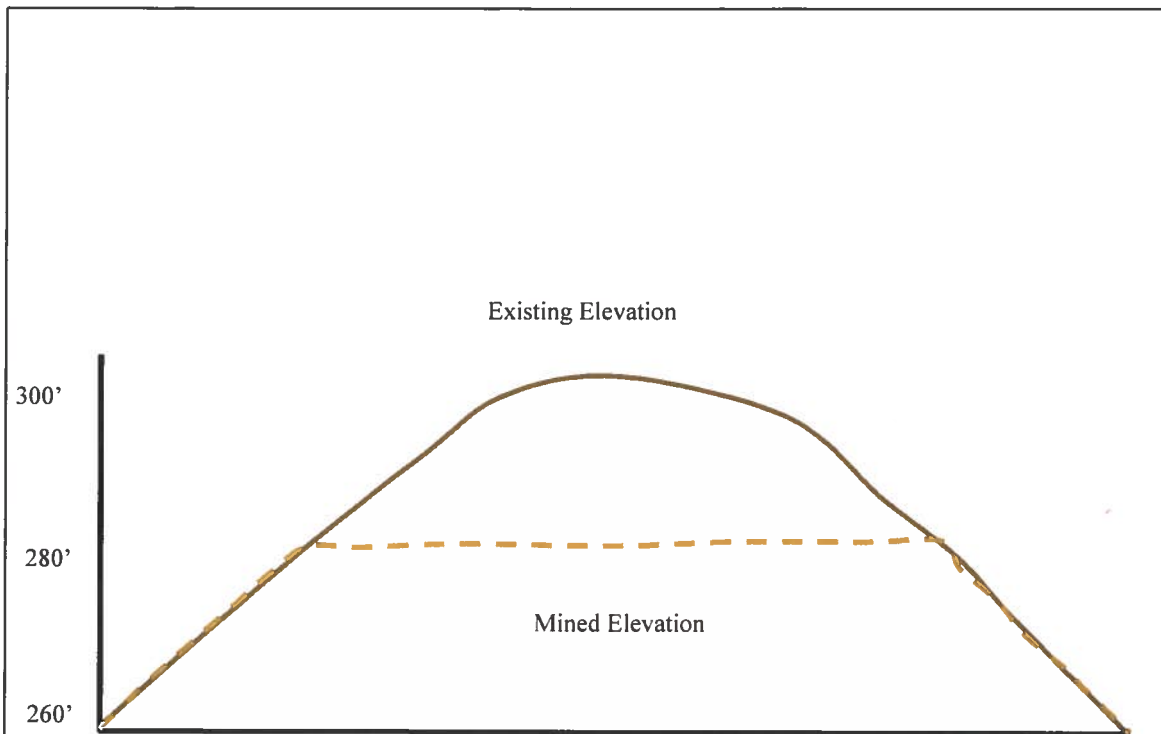
Looking from East to West
Profile Running South to North

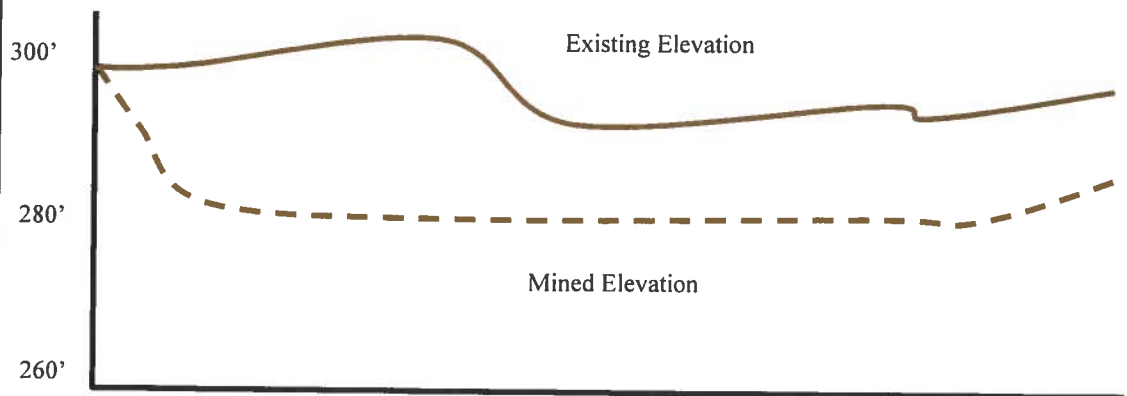
Looking from South to North
Profile Running East to West
